TB0441 Removal of Redundant Drive Timer and Contactor

TB Number:	0441
Originator:	Gareth Green
Machine:	Flowlines
Date:	30/04/19
Circulate to:	; Service;
Title:	Removal of Redundant Drive Timer and Contactor

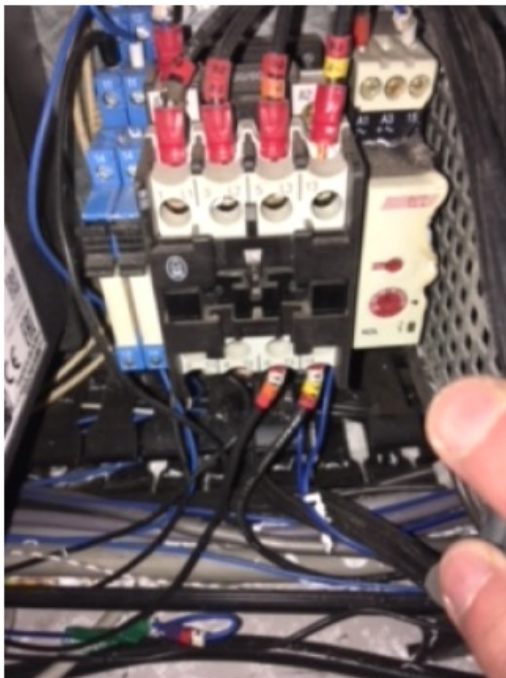
The timer and contactor were added 15 years ago on flowlines when the old DOS PC used to have a boot-up problem due to the drives switching on at the same time as the PC power supply, causing a power drain.

On a Windows PC, the original issue is no longer a problem, so the delayed start is not needed. If the timer or contactor parts fail, they can be removed, and the contactor bypassed.
