Common Issue - Autoflow GZ Datum Sensor Bracket Bent

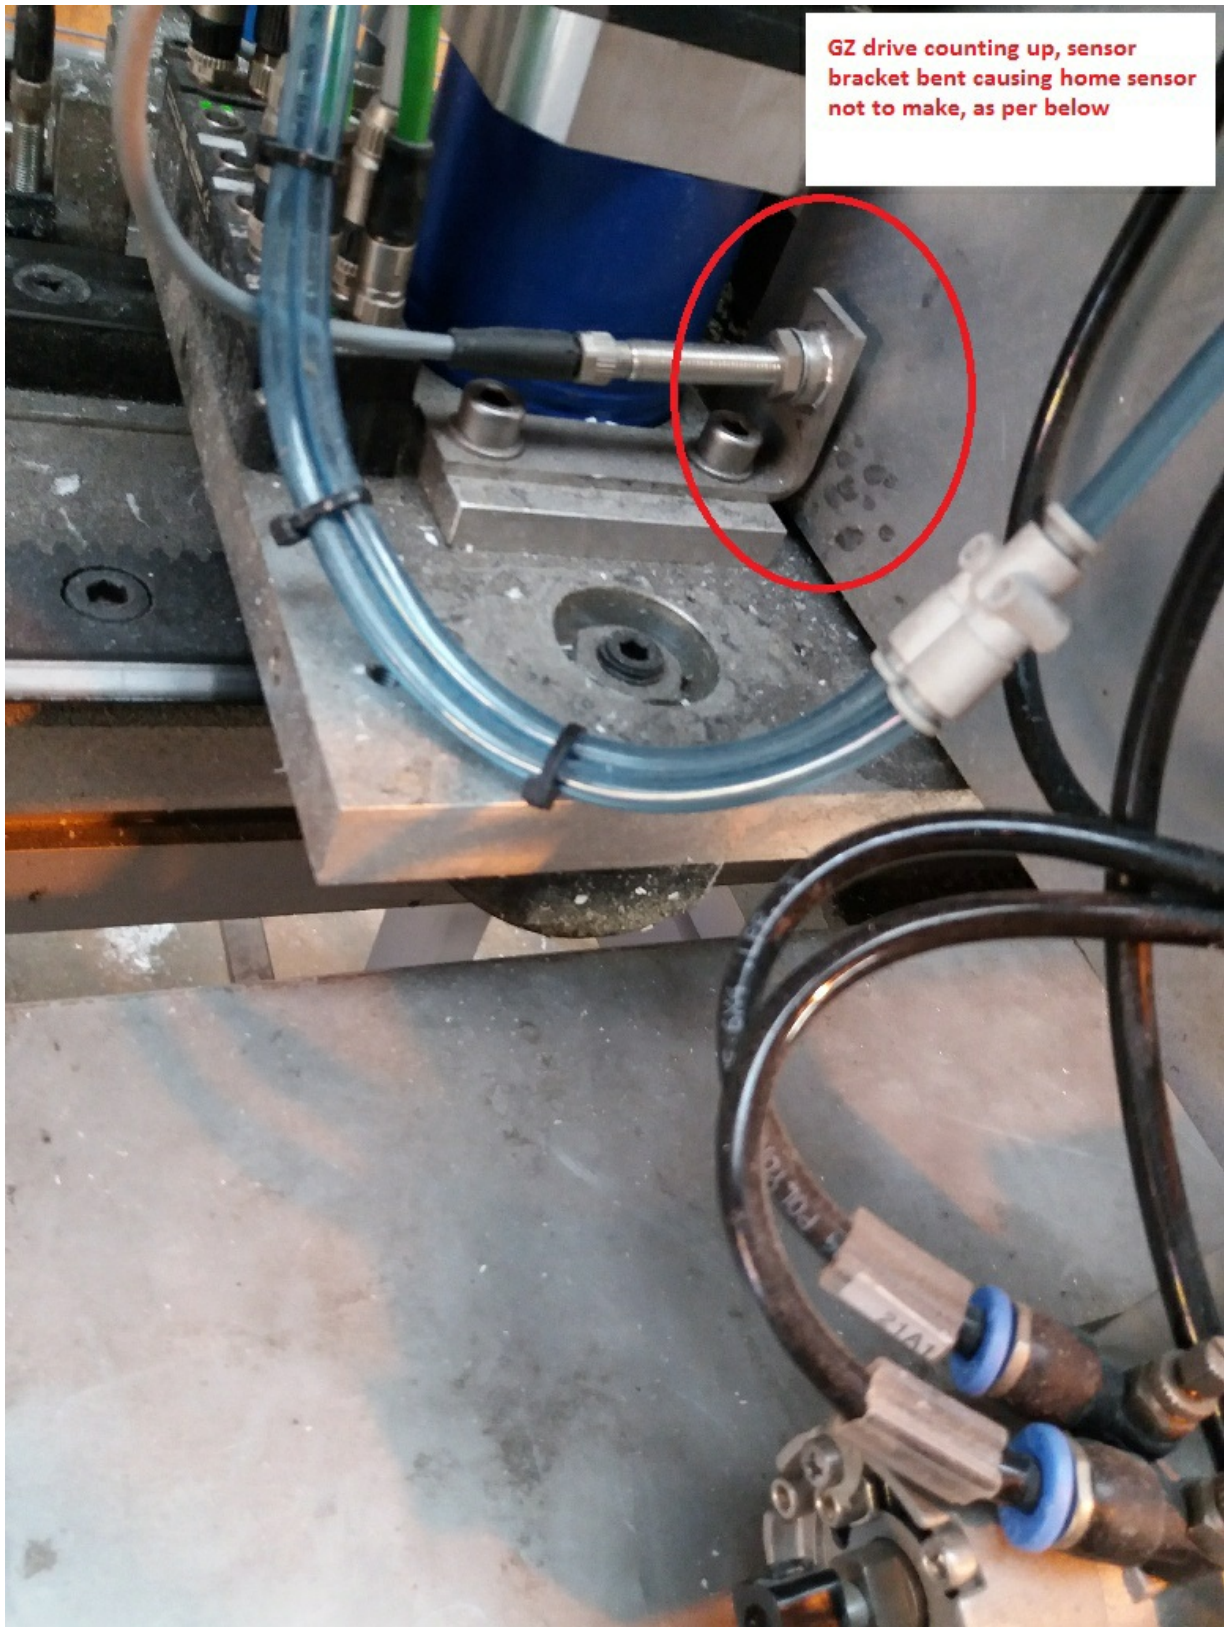
Sensor bracket bent meaning sensor cannot detect edge of profile

Bend bracket back into place

Check/ Adjust sensor position relative to aluminium component - there should be a 0.5mm to 1mm gap
