Fichier:Reinforcing Forward Clamp Energy Chain System 3.png

Stuertz Infeed - Reinforcing Forward Clamp Energy Chain System

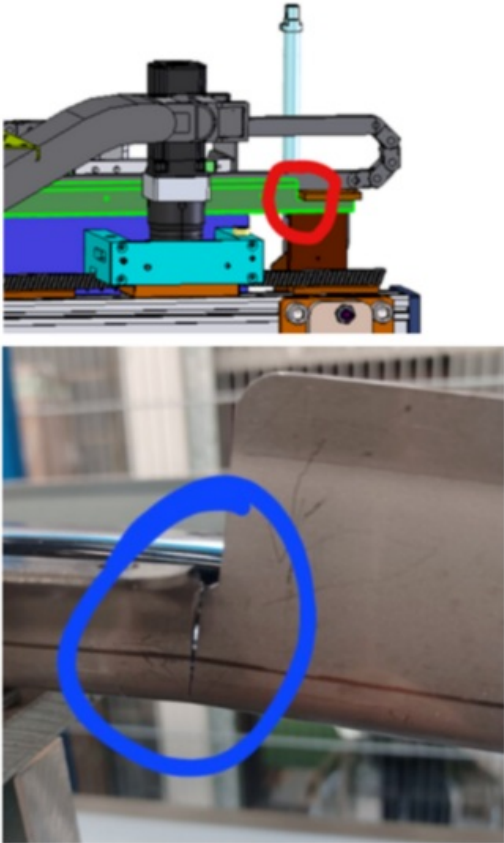
Energy chain tray stress fracture on 421312
