# Mk10 Gripper Setup

Correct Setup of Mk10 Gripper on Flowlines & ZX

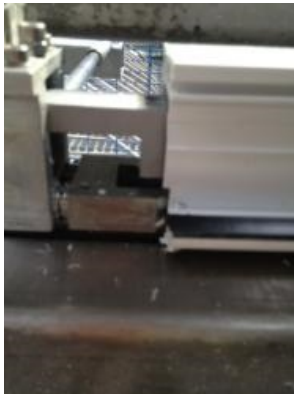
Problem identified at Ultimate 70 and Vale after Mk9 / 10 Universal gripper upgrade fitted. When trimstart is used, there is a potential for the profile to bottom out on the grip jaw holder rather than the gripper nose itself. (see photo)

Pos test will be different when using an offcut (plain end, no trimstart applied) and a full bar length. Accuracy will be affected as the whole trimstart function is negated.

Gripper nose end stop position is not correctly adjusted. The datum point (before and after trimcut) should **always** be the gripper nose, **NOT** the gripper jaw holder. Also check that the trim amount is not too big, this is controlled by the loadpos parameter- it should be 0 to -3.5, never bigger than 0.
