R0015381 Upgrade Secondary Transfer Table Sensors

Adding a secondary ultrasonic sensor to the 7 transfer loading positions to backup the flaps

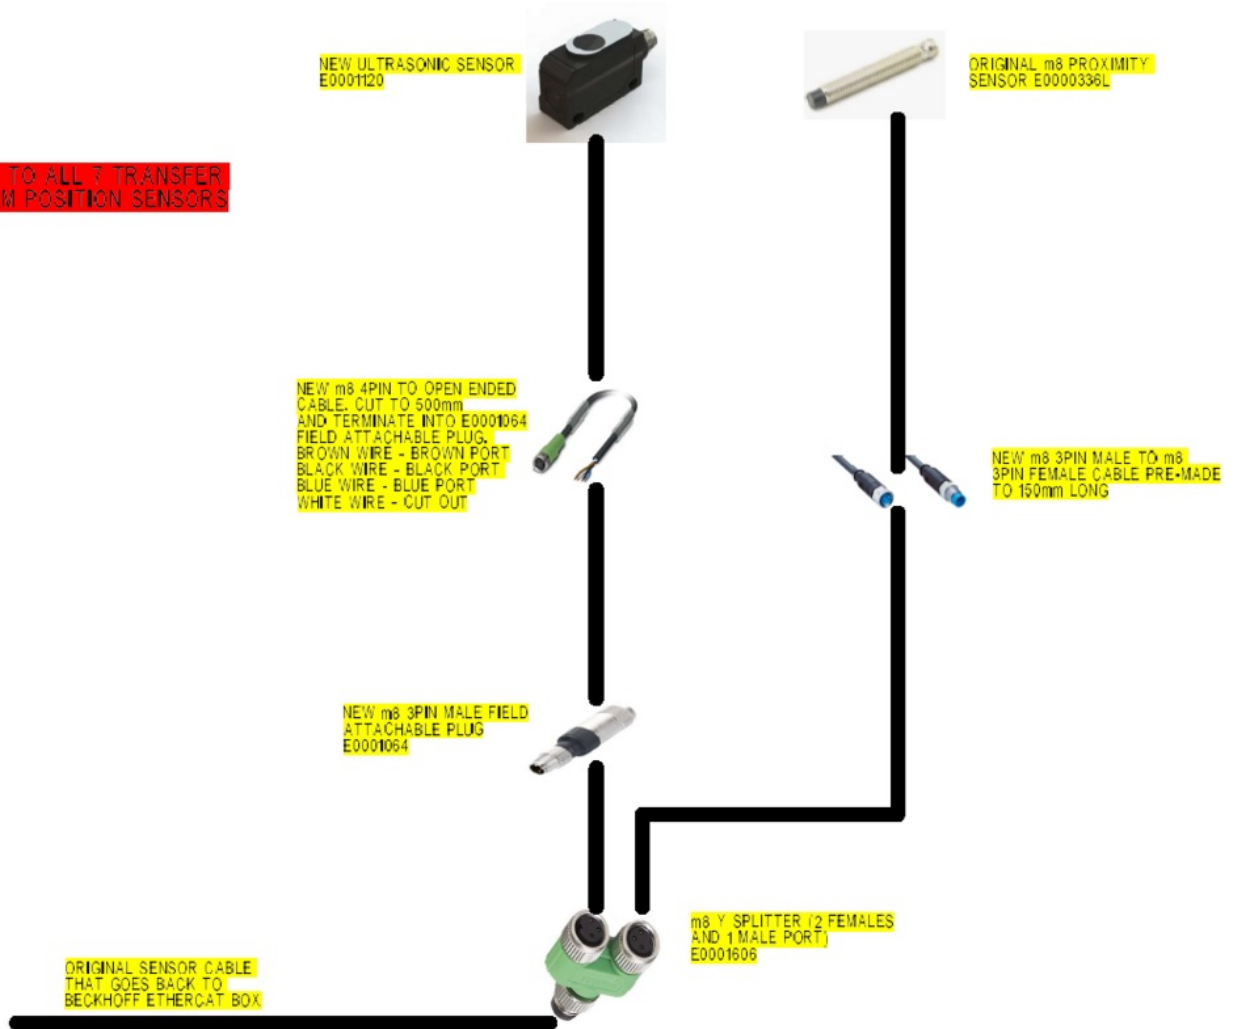
Wiring Diagram (one for each flap)

If bars are bowed at one end, the transfer table flaps may not depress enough to activate the sensor. The sensor is limited to 4mm in its sensing range

A simple-fit system has been designed to provide a secondary backup to the flap using an ultrasonic sensor and an M8 Tee Splitter. This is a plug and play solution that does not require any reprogramming or additional IO channels.

THIS APPLIES TO ALL 7 TRANSFER FLAPPER BEAM POSITION SENSORS
