Root Cause Analysis - Tool break when spindle not starting at beginning of bar

Root cause analysis of drainage tool breakage at the start of a bar

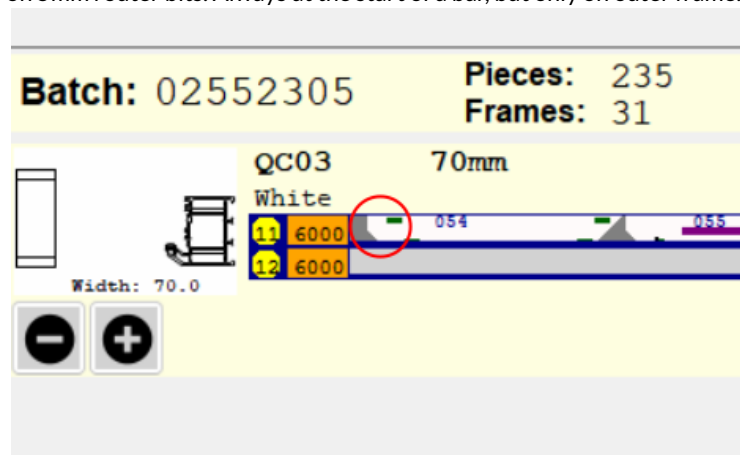
Seemingly random tool breakage on 5mm router bits. Always at the start of a bar, but only on outer frame.

The video of the drain slot operation shows the spindle plunge, then the x axis move before the spindle switches on. This is incorrect - the spindle should switch on before the movement happens.

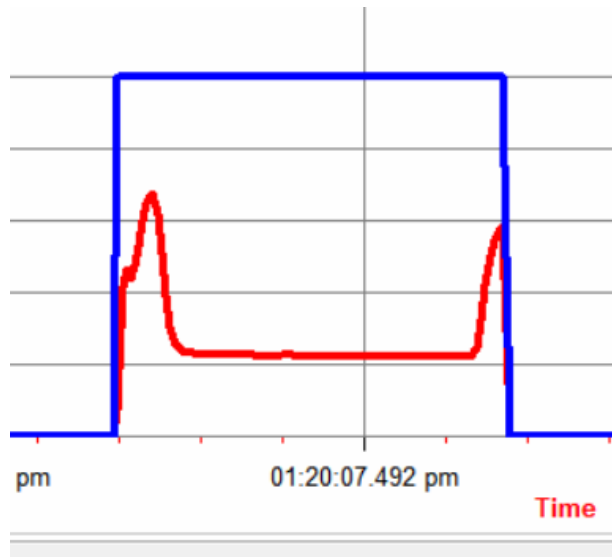
Running the spindle on the IO screen shows no issues at all - the cycle can accelerate and decelerate all day long with no inverter errors.

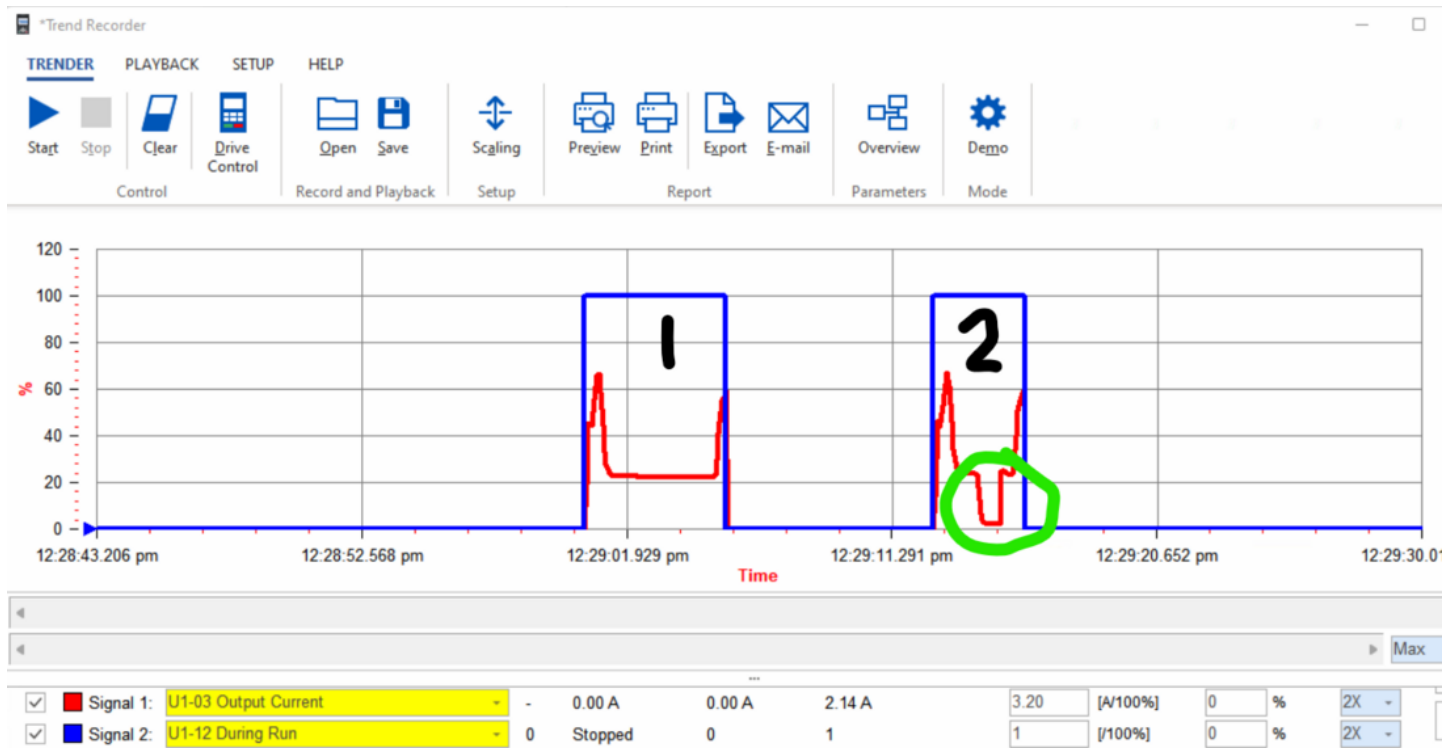
Running the trace during the repeatable break situation showed an anomaly (below). This trace was repeatable each time the operation at the start of the bar was run

The first trace (1) is the result from the datum holes - the red peaks show the current peaks when accelerating then decelerating. The second trace shows the fault where the red trace shows the current dropping. The blue line shows that the inverter has not created this dip. Because the red trace is a measure of output current, the dip must be reflecting a physical interruption in the current passing to the motor. The blue trace proves that it is not the software "RunFwd" output or the inverter doing this, therefore it has to be an external connection or relay problem.

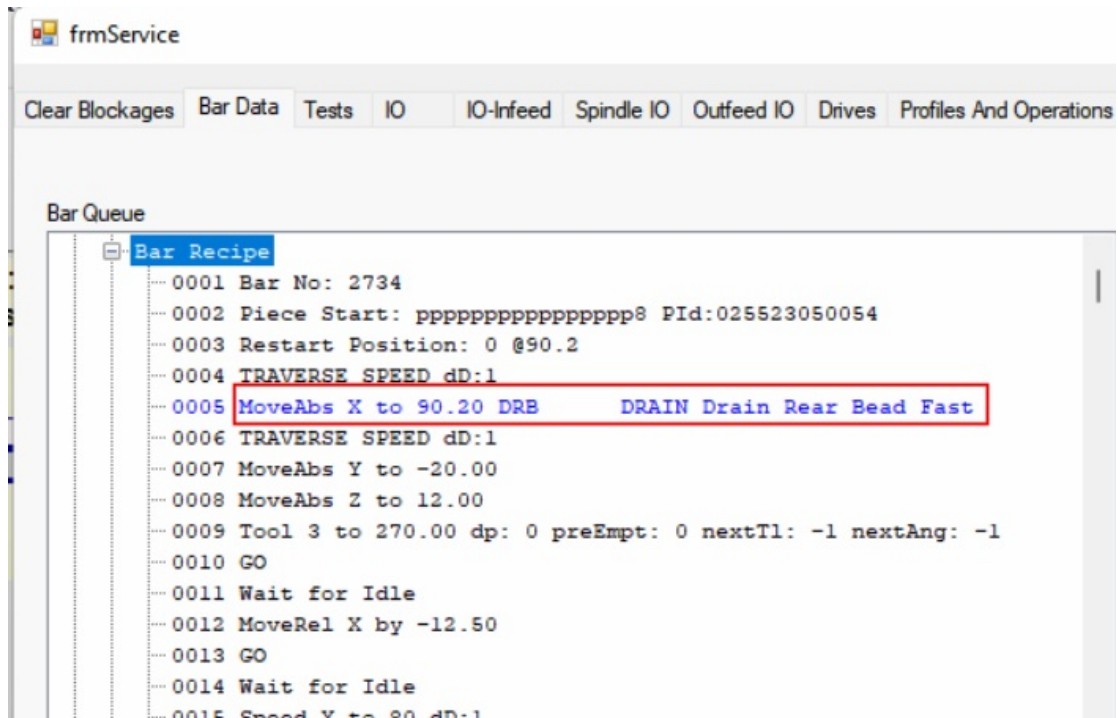
To see if this is a mechanical location issue, Set up the X, Y, Z, R axes on the machine to the actual axis positions during this operation. These positions are taken from the bar recipe

Axis	Position	Notes
X	90.2-12.5=77.8	Position of operation minus the startOffset for a drainage slot
Y	-20	
Z	12	
R	315	Spindle 8 at 270 degrees

Attempting to run the spindle in these axis positions uncovered the root cause - the spindle relay output (SPIN8) was not able to switch on.

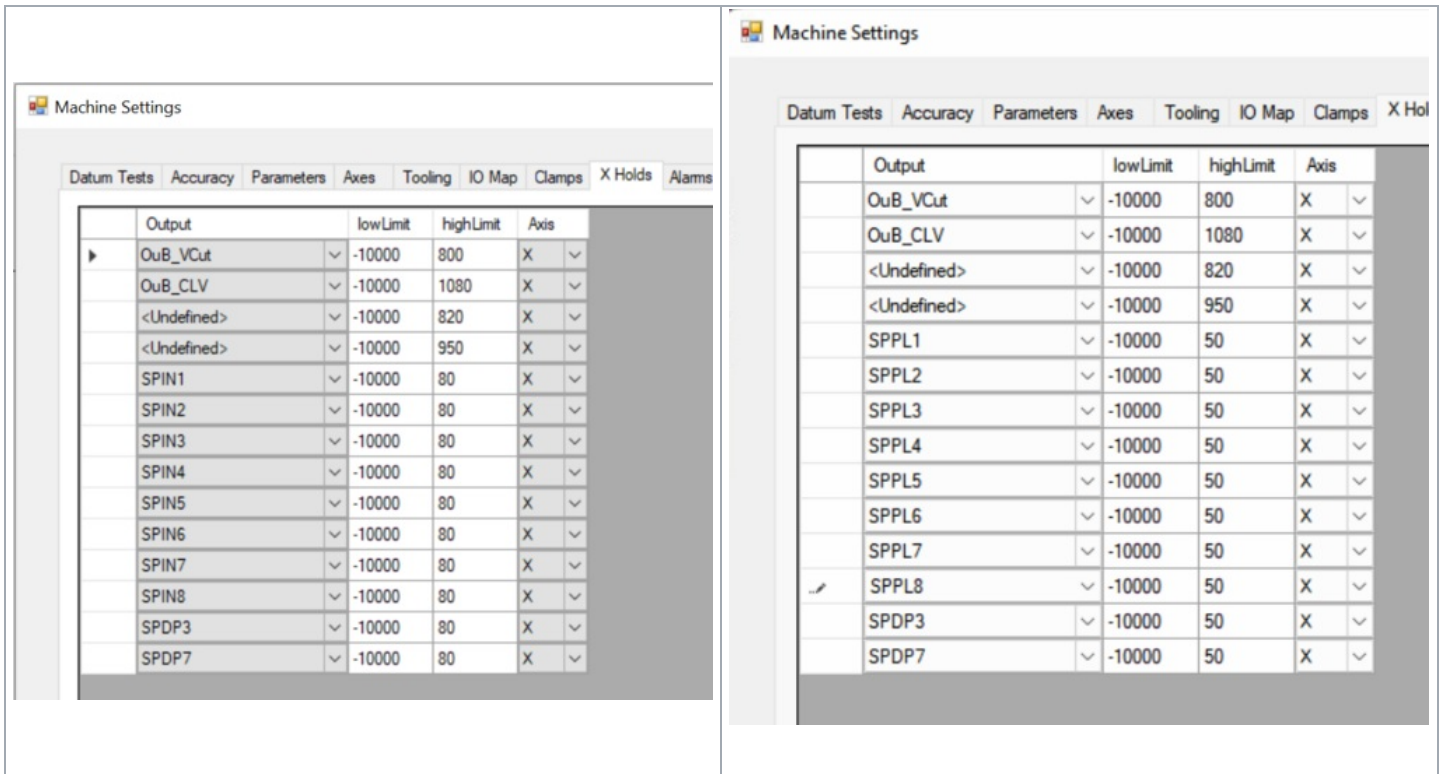
Before	After
--------	-------

The solution lies in a set of parameters called "xHolds". These parameters are there to prevent an output from switching on and clashing with the gripper if the x axis is in a certain location. On this machine setup, the xhold for SPIN8 was set to 80. When the operation occurs, the x axis position is 77.8, therefore the SPIN8 output is held off until the x axis moves to a position >80mm

The use of SPINx in xholds is actually incorrect. The correct output to prevent clashing with the x axis gripper on a ZX5 is SPPLx (Spindle Plunge). SPINx refers to the control relay.

To resolve, change the xhold parameters to SPPLx and reduce to 50mm
