Stuertz Infeed - Reinforcing Forward Clamp Energy Chain System

Instructions on reinforcing the energy chain on Stuertz infeed table forward clamp system

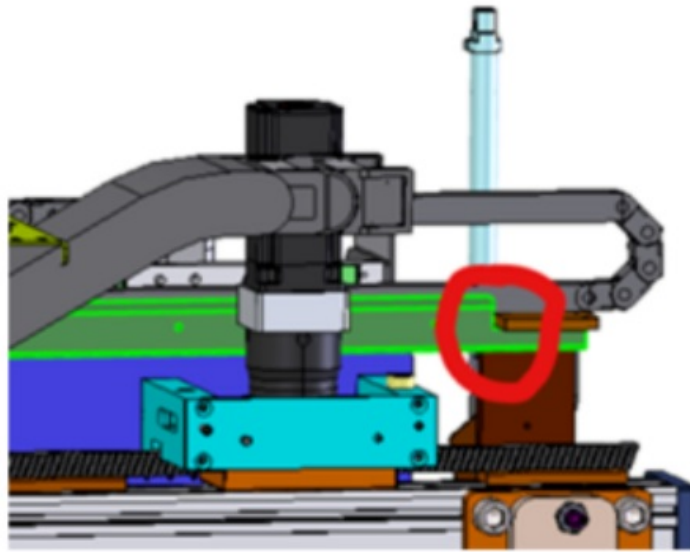
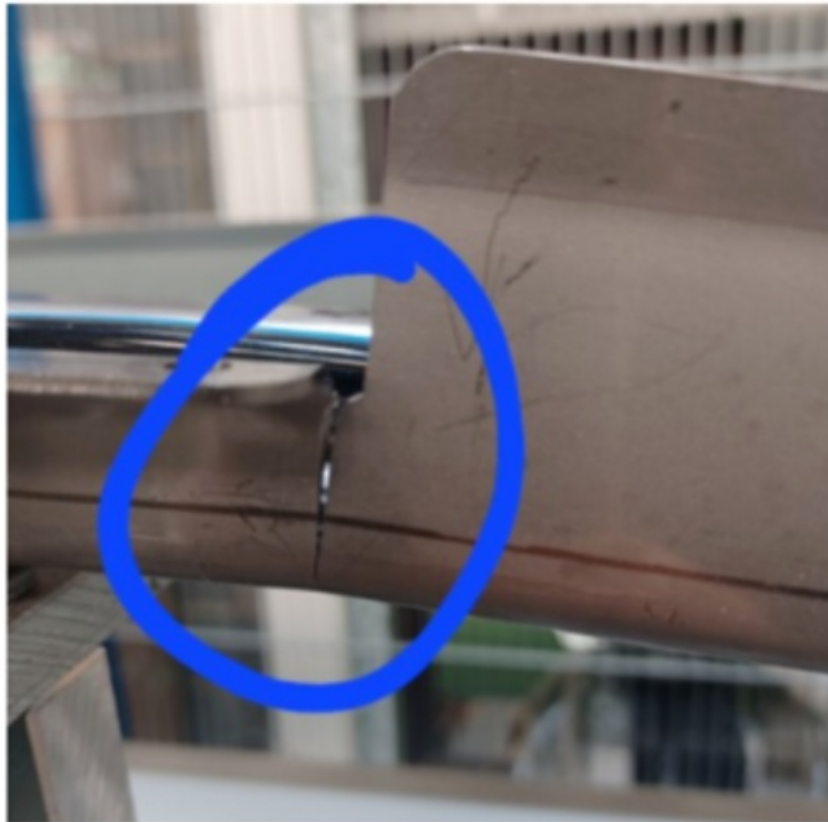
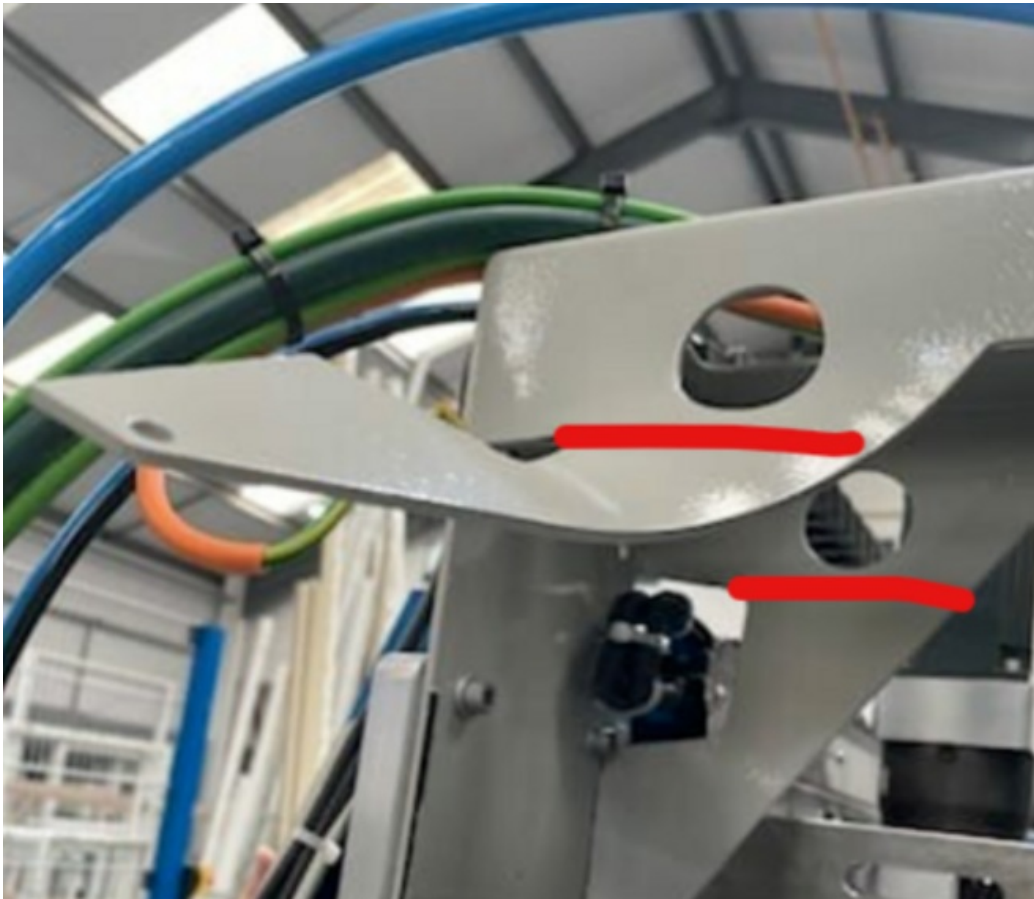
On A2030, the energy chain tray for the forward clamp was splitting along a seam and breaking. This, in turn put the tray in misalignment with the hole in the main energy chain tray mount. This led to a catastrophic failure of the system.

Energy chain tray stress fracture on 421312
