TB0266 Grip released Sensor Upgrade

Retrofitting Grip Released sensor on Autoflow

TB Number:	266
Originator:	Gareth Green
Machine:	Autoflow
Date:	24/09/14
Circulate to:	Internal
Title:	Grip released Sensor Upgrade

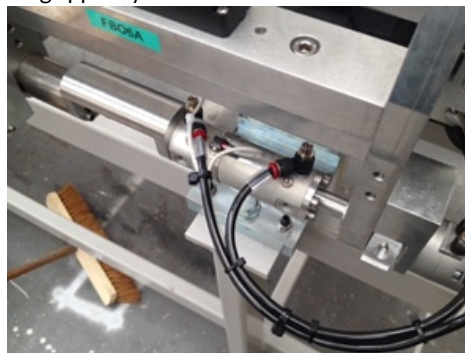
Gripper sticking shut at end of bar on Autoflow. Can lead to damage to clamps

Fit R0010271 upgrade kit to put a sensor X001 on gripper cylinder to detect if released.

Sensor P0001013 should be labelled X001 and has cable and M8 connector already attached.

Plug into FB06A port 2.

Reed switch needs

P0001041 mounting bracket and P0001042 mounting band

to fix to cylinder body.
