TB0402 Modification to Autoflow Concertina Door Slide Pin

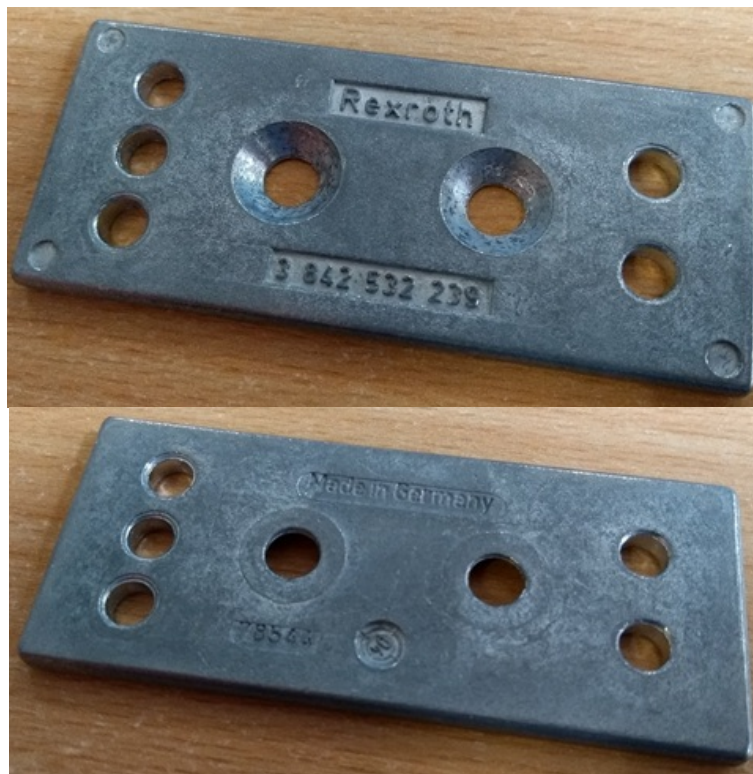
Stuga P/No M0001024

There are regular reports of the concertina doors coming out of their slideways on the Autoflow. The moving end of the door is meant to be contained using a kit which has a plate bolted to the underside of the door, and which has a downwards facing plastic top hat bush. This bush is located using a dowel which is press fitted into the plate. Over time, the dowel works loose and falls out, resulting in the top hat bush falling away. Part number M0001024

The unmodified plate is shown below:
