TB0406 Procedure to replace drive on TwinSAFE systems

Replacing a Beckhoff Ax5000 drive on 2016 onwards systems has complications due to the TwinSAFE system

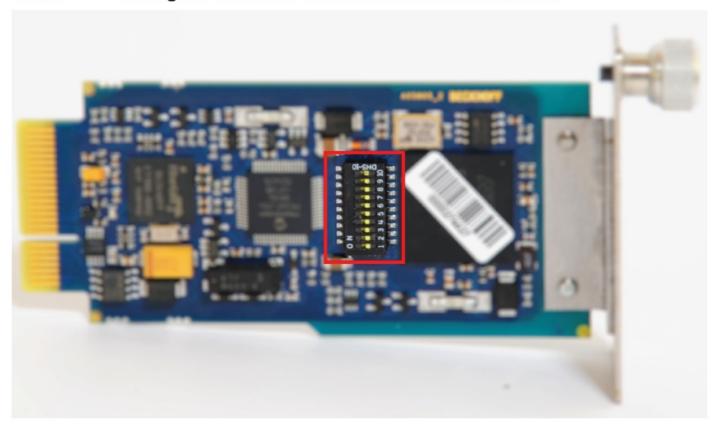
Fig. 2: DIP switch for setting the TwinSAFE address

If the Safety card is faulty and needs to be exchanged, the switch settings should be changed to match the replaced card

You must set a unique TwinSAFE address using the 10-way DIP switch on the AX5805/AX5806 TwinSAFE drive option card. TwinSAFE addresses between 1 and 1023 are available. Address 0 is not permitted.
