TB0418 Use of Plastic Reinforcing On Stuga Machines

As the development of uPVC systems has advanced, there is greater and greater use of pre-reinforced profile on Stuga machinery. The profile is often made of a recycled plastic and is inserted into full lengths of profile. It is fixed using a series of staples along the length. The machines were not originally designed with this in mind. We have experienced four serious issues from testing this system in the field.

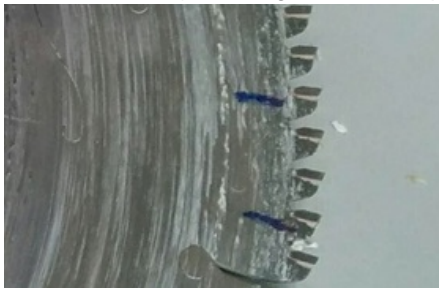
Steel staples are often used to attach the reinforcing to the profile. This creates a very big problem for the router bits and the saw blades on the machine. They are designed for uPVC profile, so when any kind of steel is encountered, no matter how small, **it will damage the tooling.**

This results in chipped teeth on the saw blade that cannot be repaired or re-sharpened, and if undetected will lead to **chipped profiles, accuracy problems** and will **permanently destroy** the saw blade.

Steel also very quickly destroys the cutting edges of expensive carbide router bits, leading to a reduction in their performance, thereby overloading the spindle motors and leading to **premature spindle motor failure.**

Aluminium staples can be used, as the cutters and blades will not be damaged.
