TB0442 Removing Slot Overrun on Beckhoff AX8000 Drives

Difficulty Medium

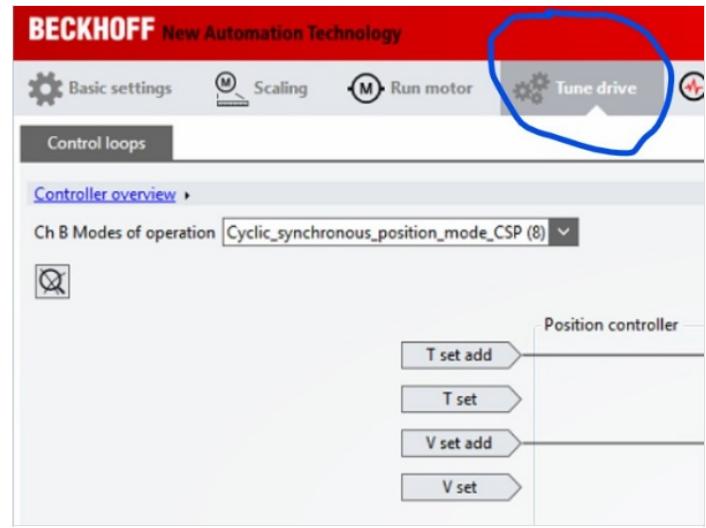
Step 2 - Select the Tune Drive tab

Select the Tune Drive Tab. The Velocity constant is T_n . This screen shows it in seconds (0.008s = 8ms)
