TB0452 Ecoline using RSAutomation EtherCAT setup notes

TB Number:	0452
Originator:	Gareth Green
Machine:	Ecoline with winMulti
Date:	23/07/19
Circulate to:	Service;
Title:	Ecoline using RSAutomation EtherCAT setup notes

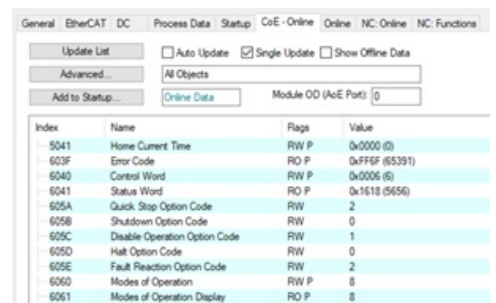
The drive needs to be set to mode 8. This is done by entering CoE Online tab for the drive and searching for 0x6060.

1. Highlight it and click "Add to Startup"
2. In the Data (hexbin) space, type "08"
3. Click OK
4. Repeat for all drives
5. Activate configuration
6. Check this is set correctly by checking the "Modes of Operation" output from drive

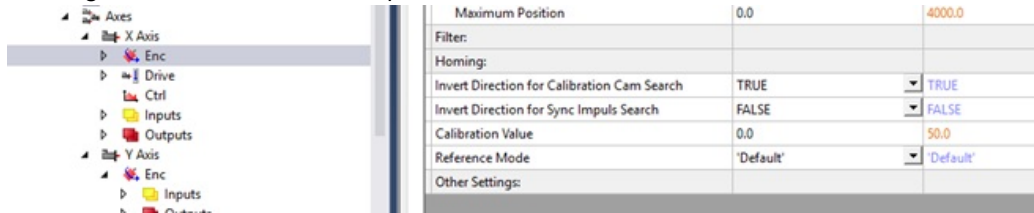
Homing directions all wrong to start with. Same reversal procedure as normal beckhoff on the Axis->Enc->Parameters->Homing set.
