Technical Bulletin - R Axis Motor Swarf Ingress Point

Issue with Swarf Ingress Point on R Axis on Beckhoff Motor / Wittenstein Gearbox Combination

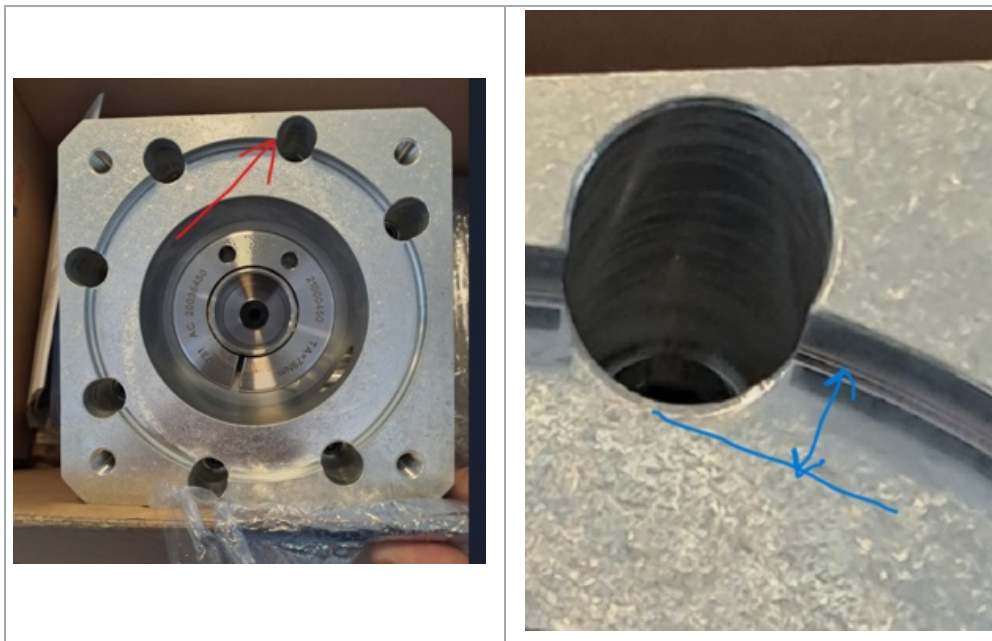
Whilst carrying out a service on ZX5 it was found that the gearbox / motor coupling area was running in compacted swarf. The end cap was there to stop ingress that way but a gap was found in the top where the 2 parts meet. This allows swarf to enter directly into the housing as all of the routing on the multi is done in this area and it just drops into the hole. This needs to be cleaned and the hole sealed as this could cause damage to the housing / motor / gearbox units.

- Remove Side Bung
- Blow out via bung hole and entry hole while manually rotating

- Push in malleable sealant
