# Accuracy - Check Gripper Datum Hole Position Variance

Accuracy Check Procedure for Gripper Datum Hole Position

ZX5 Only

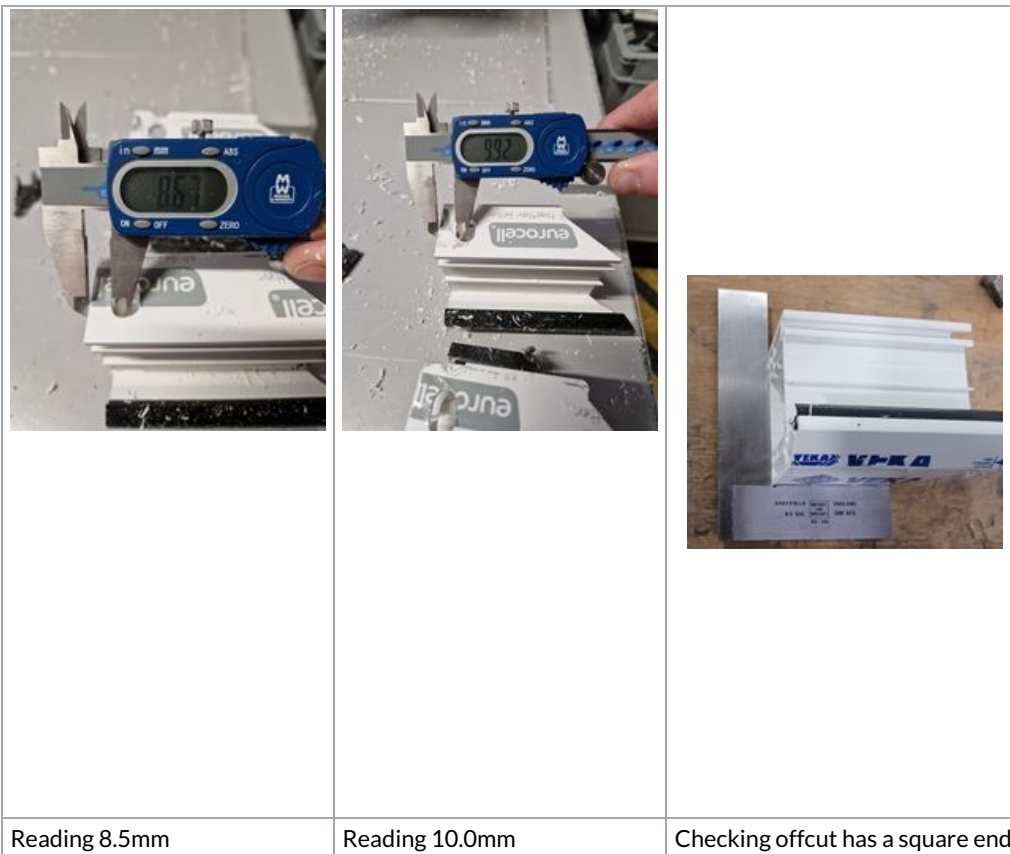
Reading 8.5mm

Reading 10.0mm

Checking offcut has a square end
