SZ Axis Bottoming Out on Autoflow

This page describes the diagnostic processes to go through to check if an Autoflow SZ axis is getting jammed with swarf at the bottom of its travel

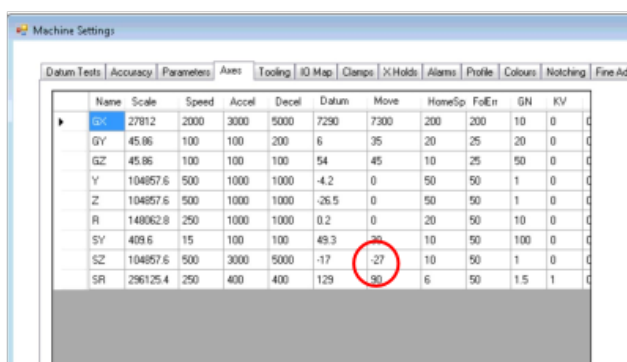
The moveAfterDatum position is found on the axes tab (in this case -27)

A work-around is to increase the **moveAfterDatum** value to a figure greater than the minimum position the SZ axis can get to.

For example: SZ axis position from drives screen = -27.1mm
moveAfterDatum value = -28.

Change moveAfterDatum value to -27mm

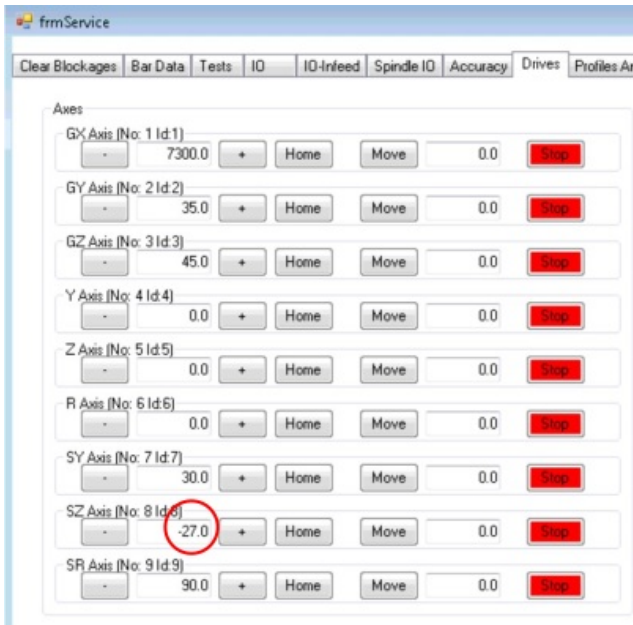
The Drives tab (from Settings window) shows the actual position of the SZ axis (in this case -27)

In the above case: Required = -27 and actual=-27, therefore the axis is not bottoming out. if the numbers are different, there is a blockage creating a problem

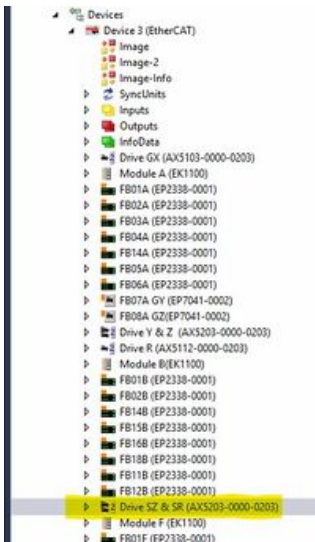
Open the visual studio project for the machine (this will be on the Camera PC) and navigate to the SZ and SR Drive:

Click on Drive Manager (1) and Watch Window (2)

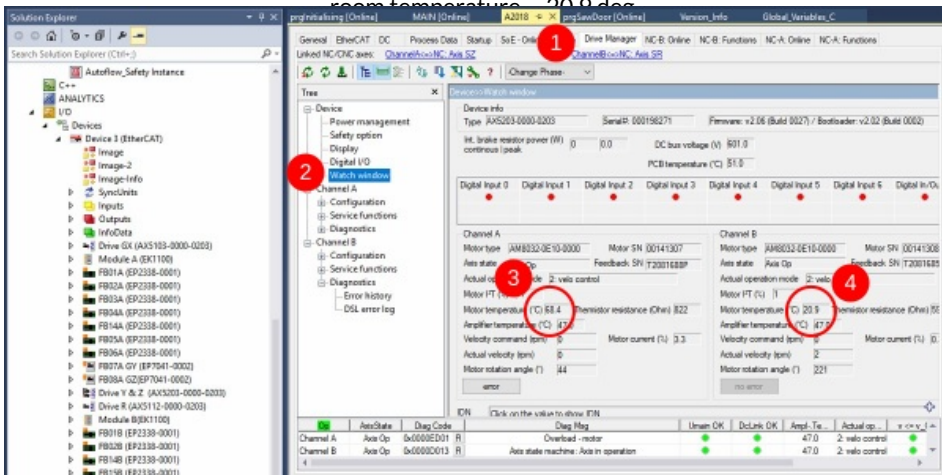
The motor temperature for the SZ axis (3) can be compared to the temperature of the SR axis (4)

They should be pretty much the same.

In this particular case, the SZ axis temperature was 68 degrees - which would be too hot to touch, the SR is room temperature - 20.9 deg

The obvious solution is to **remove the swarf blockage**, but sometimes it is not possible to get the operator to find the root cause
