Autoflow Saw Motor End Swap

The main saw motor for an autoflow D0004079 (made from E0000002) has to be rebuilt due to supplier changing the location of the terminal box.

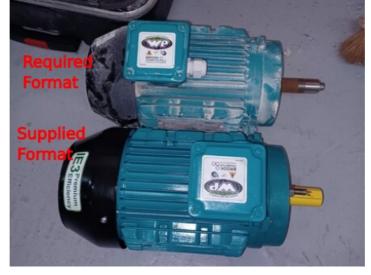
It is not possible to source the original format, so the motor needs to be reassembled in the reverse configuration to move the terminal box
