R0019207 Upgrade SR Axis Spigot

Upgrade to enhance mechanical connection between drive spigot and SR gearbox. Upgrade to allow removal of SR gearbox efficiently

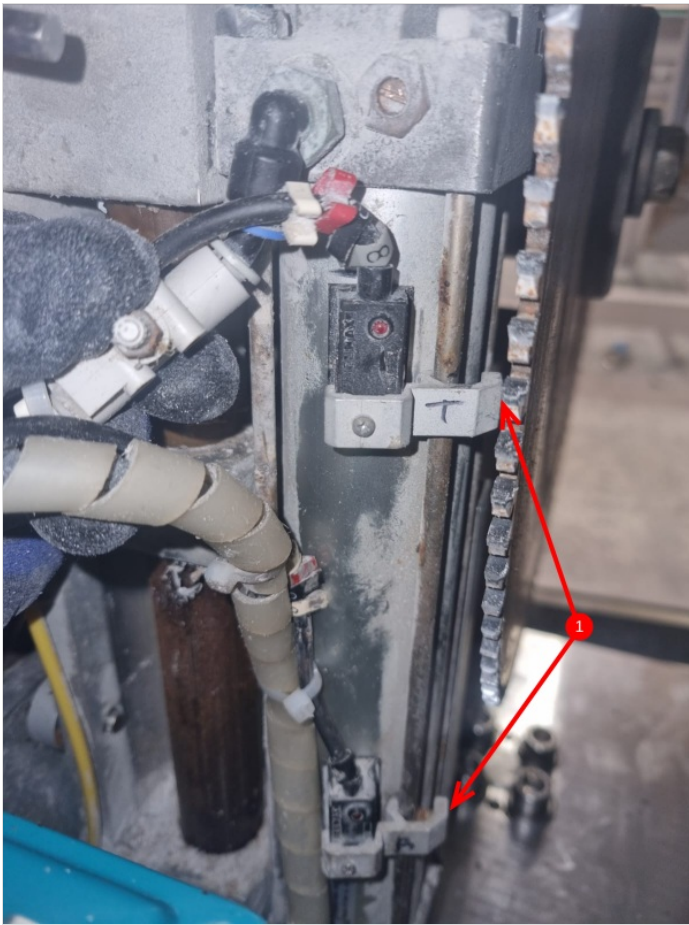
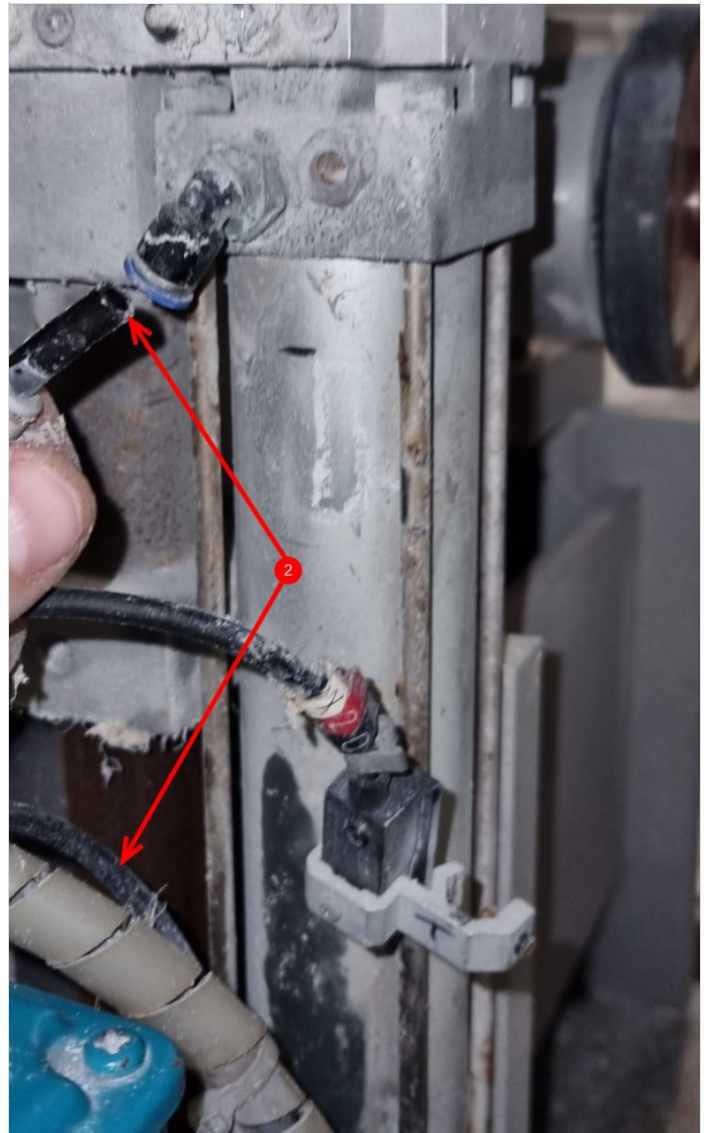
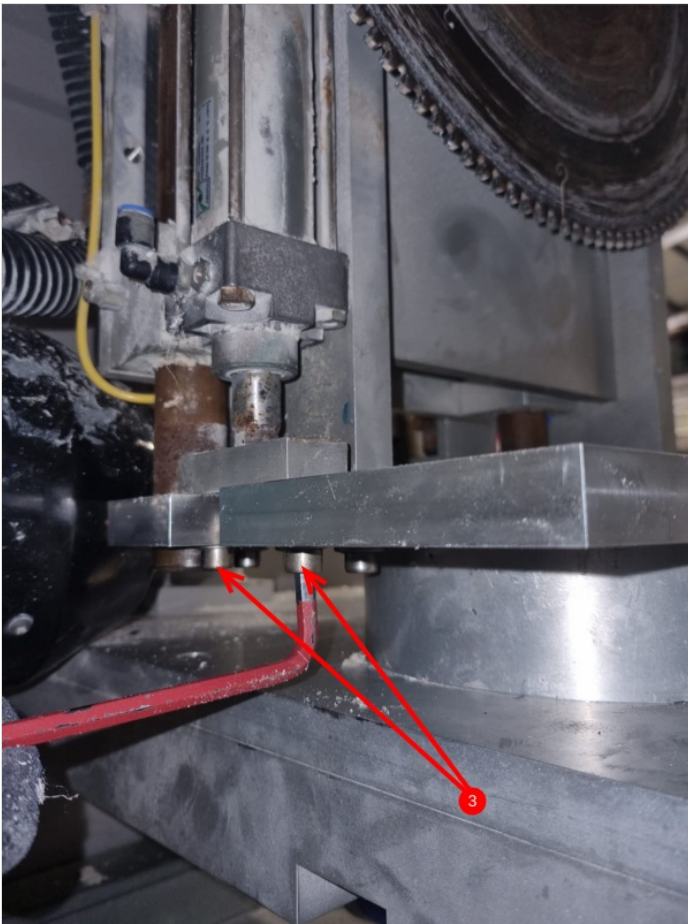
Step 1 - Disconnect Saw cut cylinder connections

1 Disconnect saw cut reed switches. Mark position of bracket before removal to aid re-assembly

2 Disconnect saw cut cylinder air pipes

3 Disconnect saw cut cylinder piston rod as shown

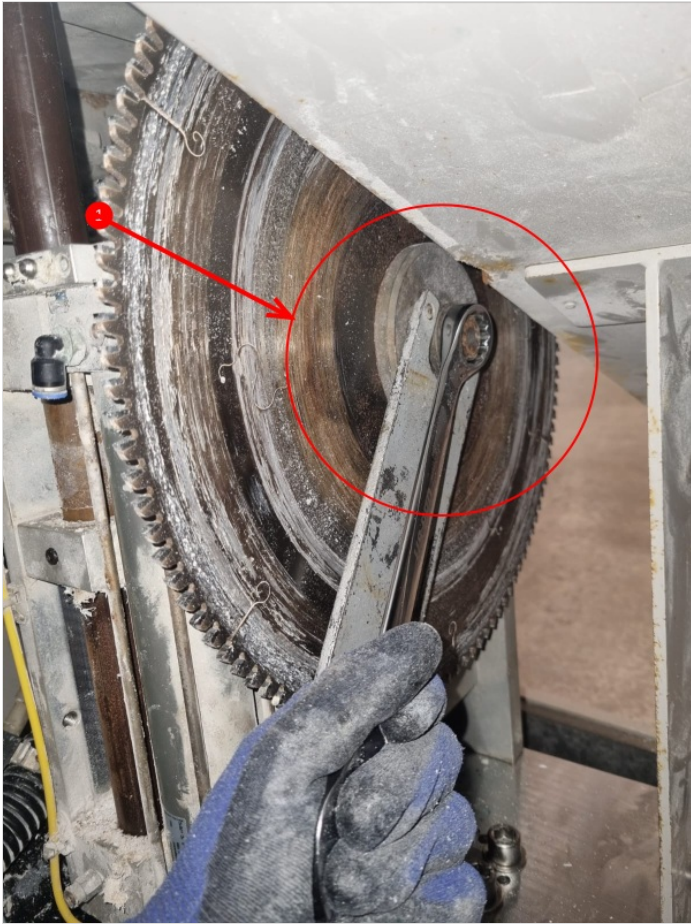
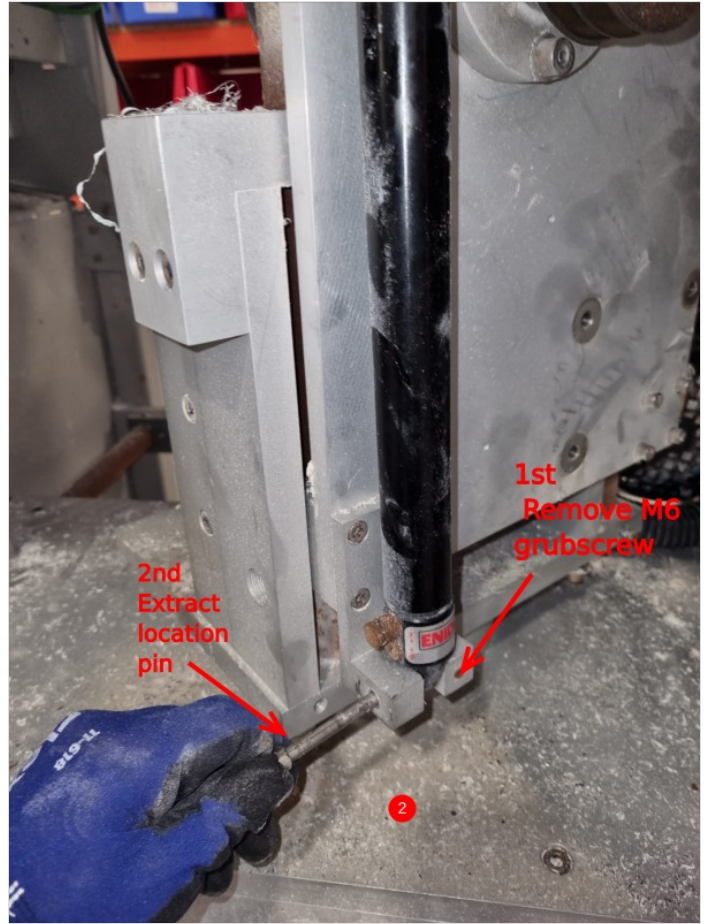
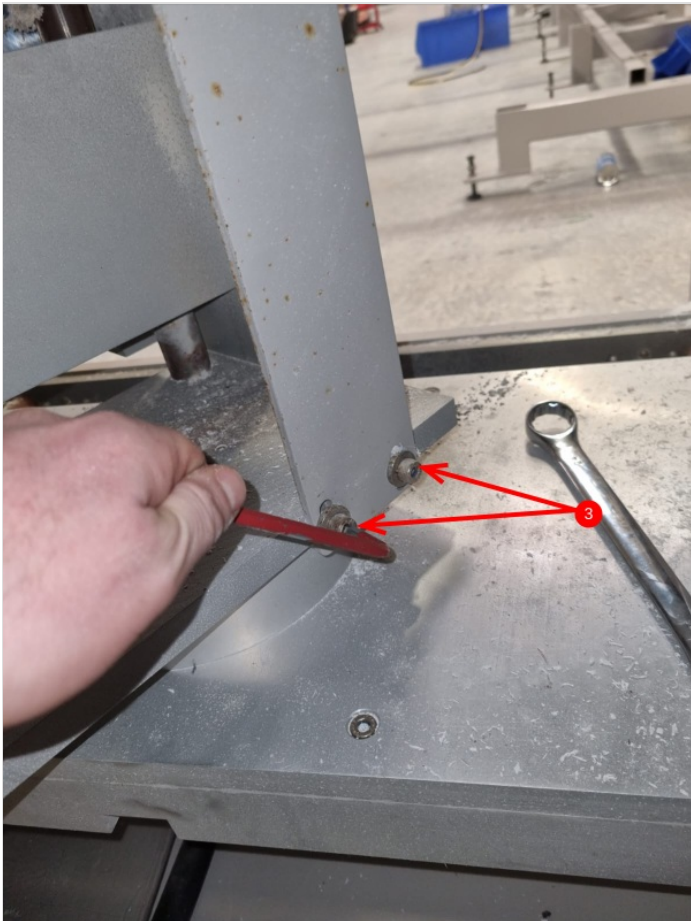
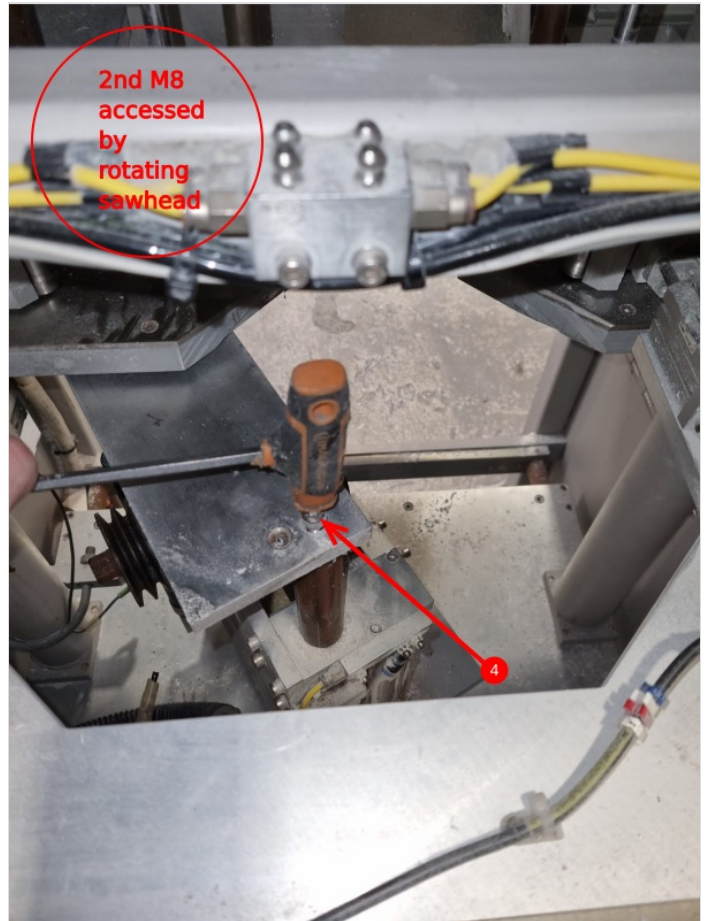
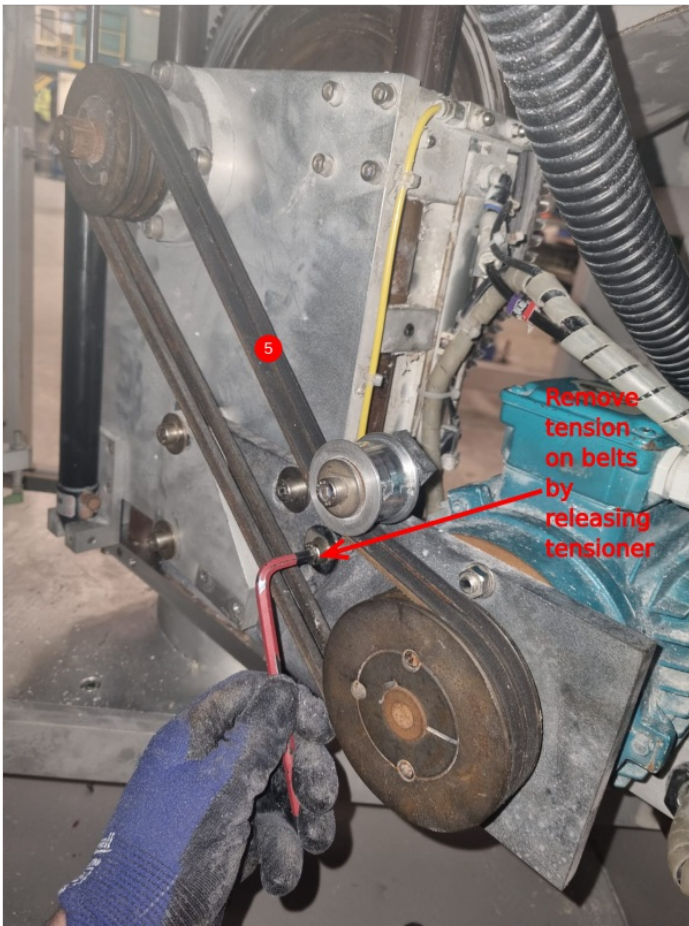
Step 2 - Disconnect Saw head guards, chutes and ancillary parts

- 1 Remove saw blade
- 2 Remove saw cut damper by removing 2 off m6 grub screws and then retracting 2 off location pins
- 3 Remove top semi circular guard with slit strips attached, remove swarf chute and supporting T bracket
- 4 Remove top brace bar located on top of saw cut shafts as shown
- 5 Remove saw motor belts

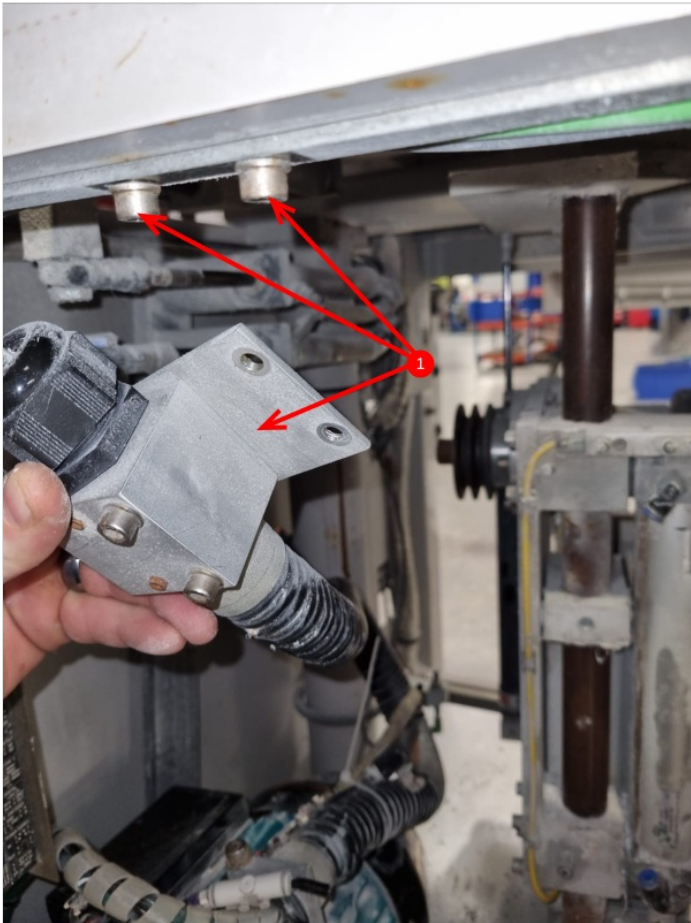
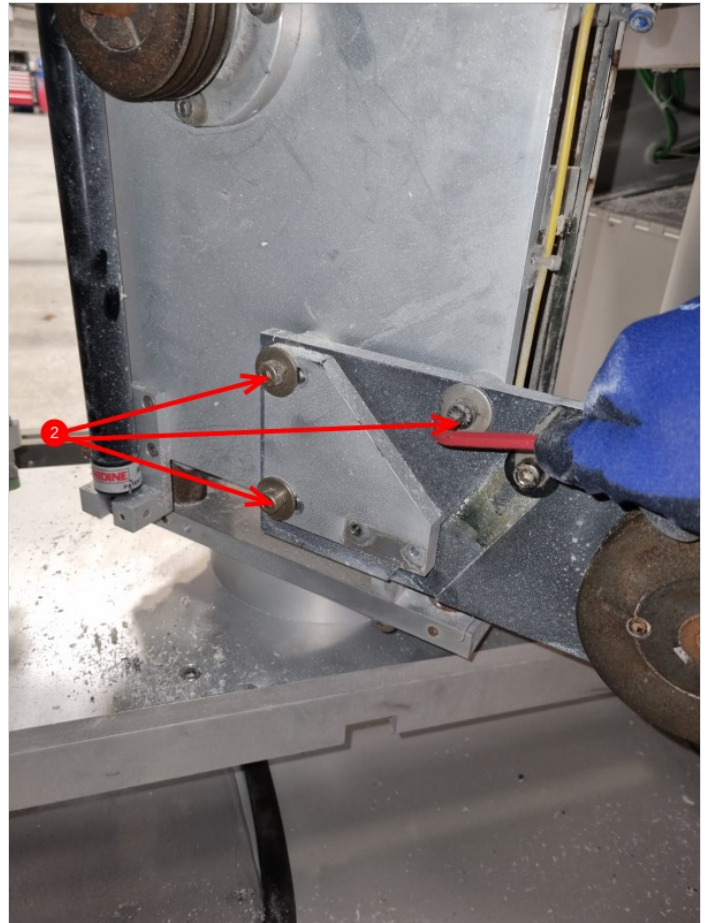
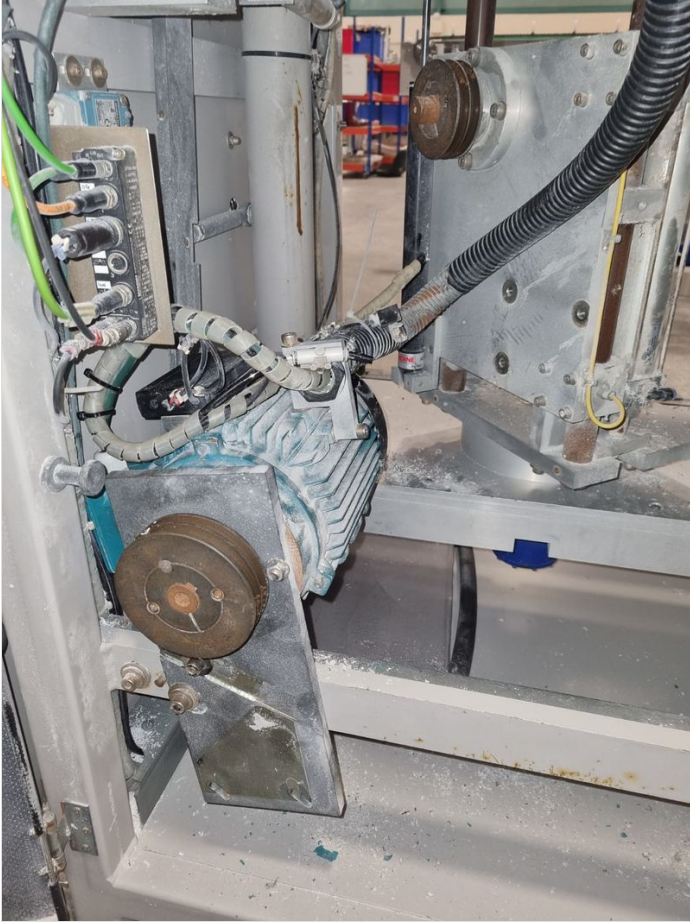
Step 3 - Relocate Motor assembly

Saw motor with mounting plate will now need removing from the saw head assembly

1 Disconnect saw anaconda as shown

2 Whilst supporting the saw motor, remove the 3 off m8 cap heads and swing the saw motor assembly and attach the frame , and secure for safe working

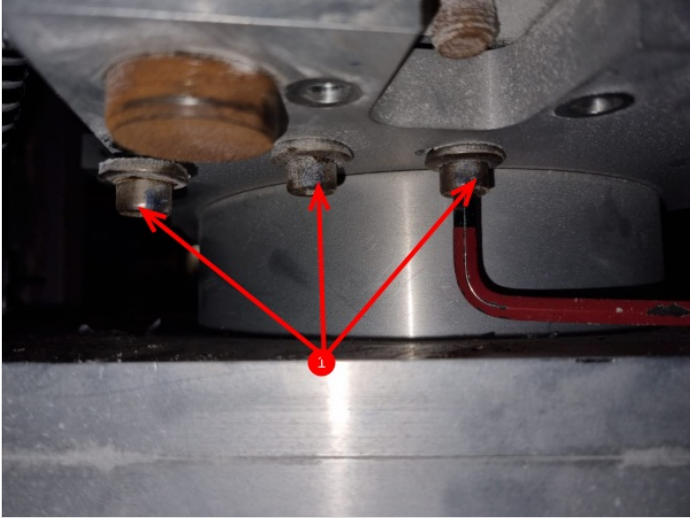
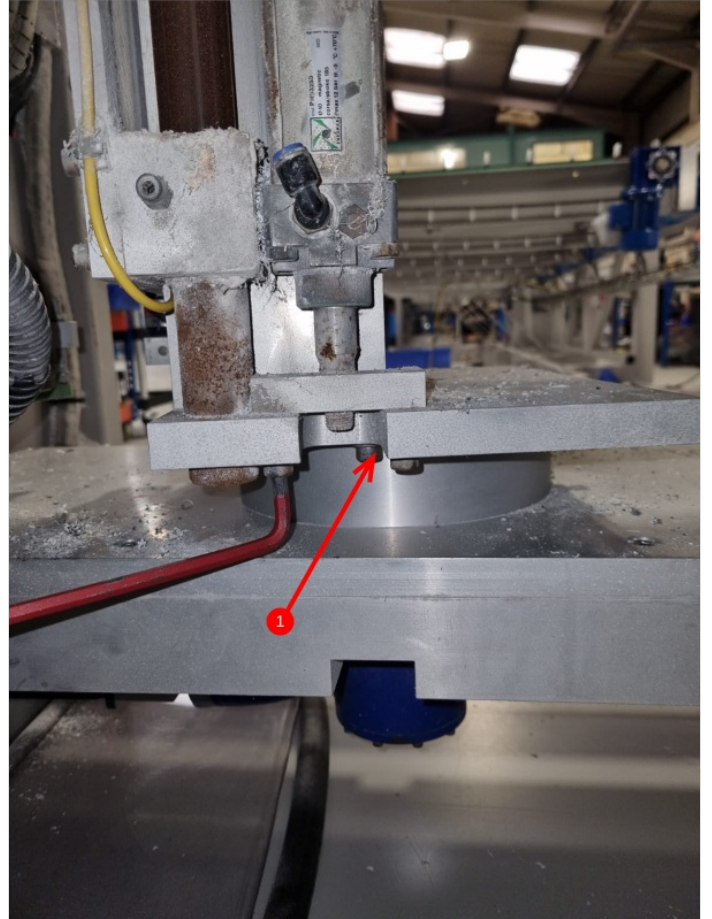
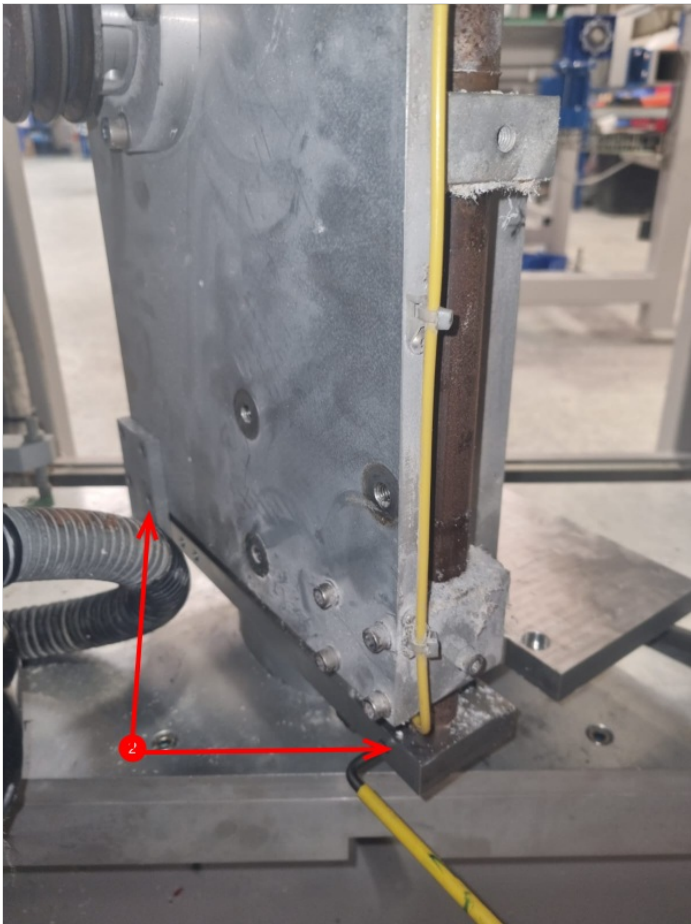
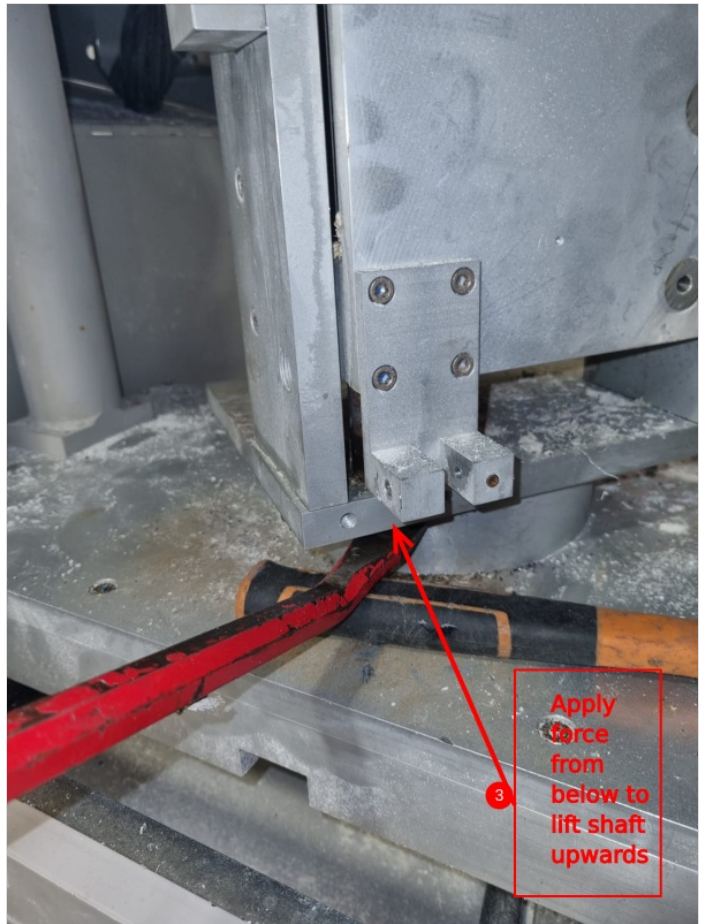
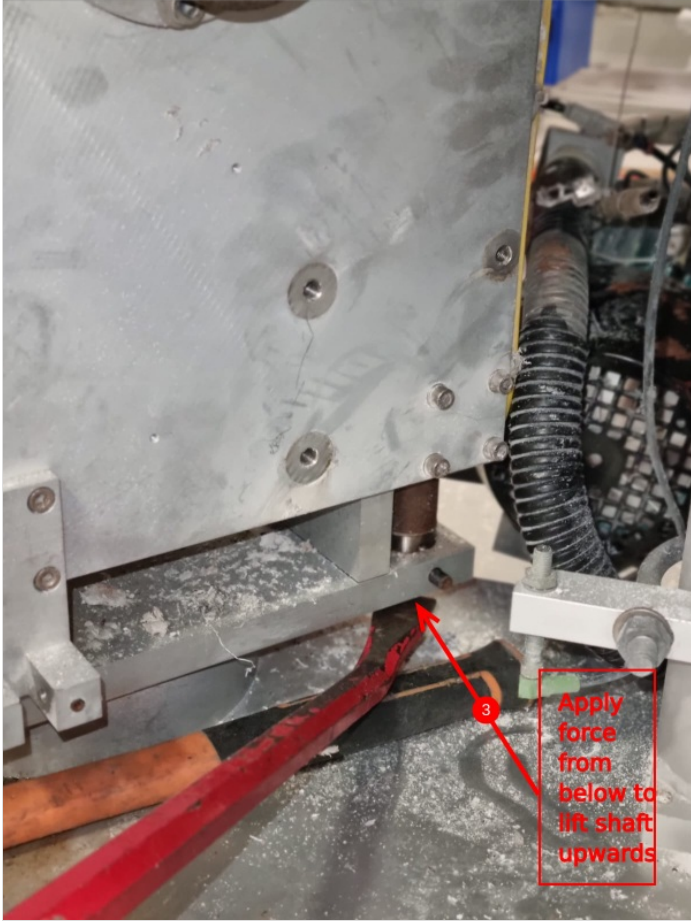
Step 4 - Main saw head disconnections

- 1 Remove 6 of M8 caps heads from underneath main saw mount plate (3 per side)
- 2 Remove 2 off m8 grub screws locating saw cut shafts to turntable base

⚠ Do not remove any other fixings on the saw head assembly when extracting. These 8 off fixings are all that are required to be removed, any additional fixings removed will compromise structure of assembly, and also mean that saw 90 degree vertical position will have to be manually reinstated once the upgrade has been completed

- 3 The head assembly can then be removed by levering the base of the two saw cuts shafts , pushing them upwards to release the complete head assembly from the turntable base

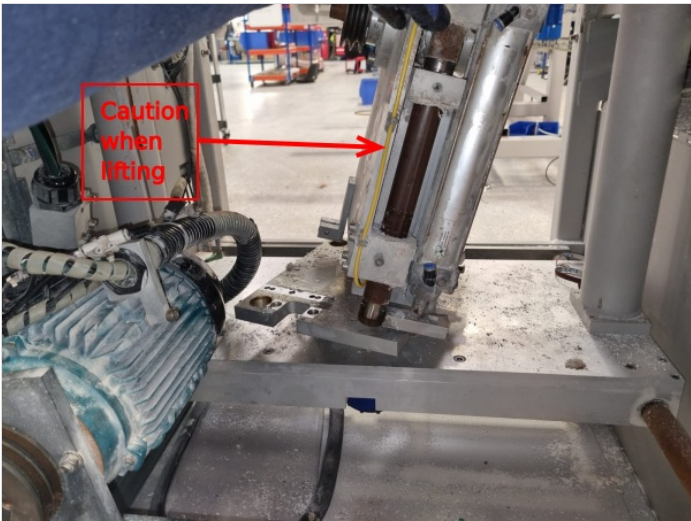
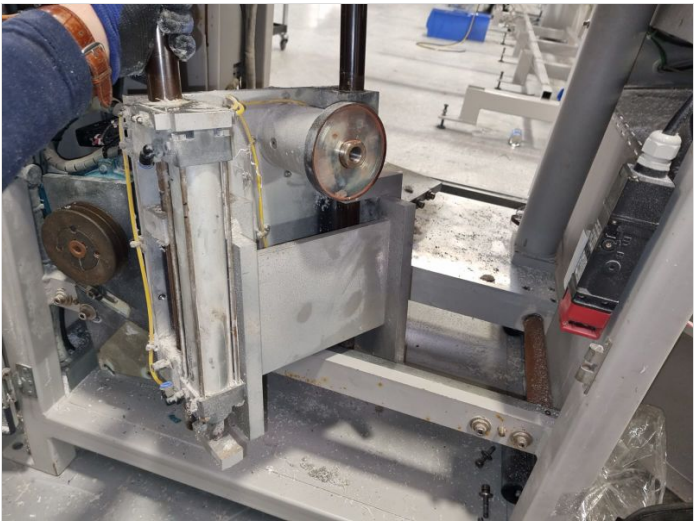
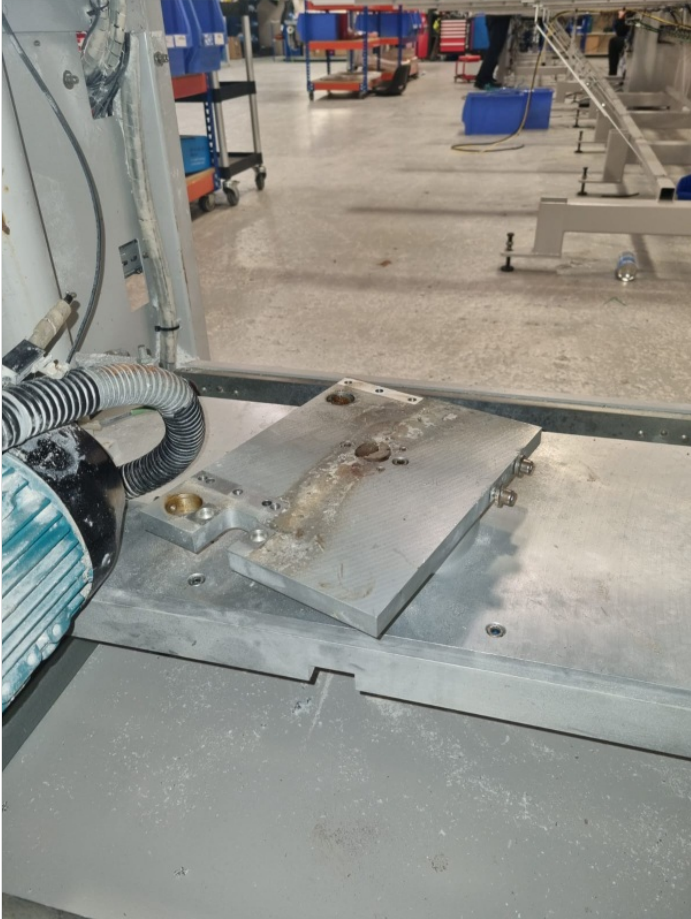
Step 5 - Remove saw head from turntable

Once the assembly is disconnected it can be removed and allow access to the turntable base as shown

⚠ ...This assembly will require a two person lift to remove from main saw area

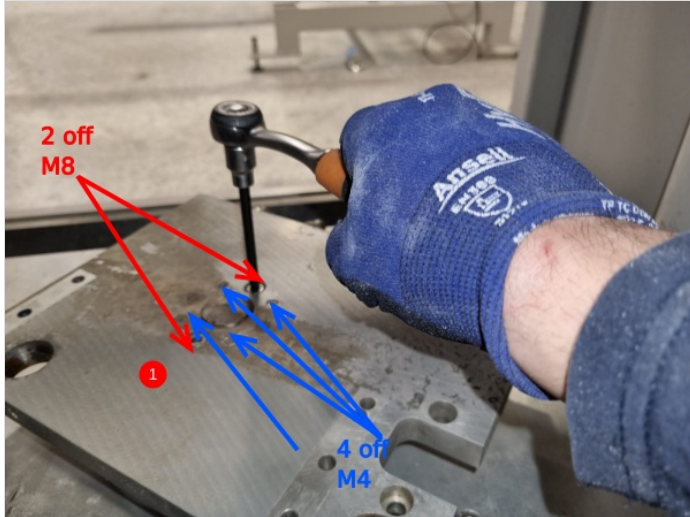
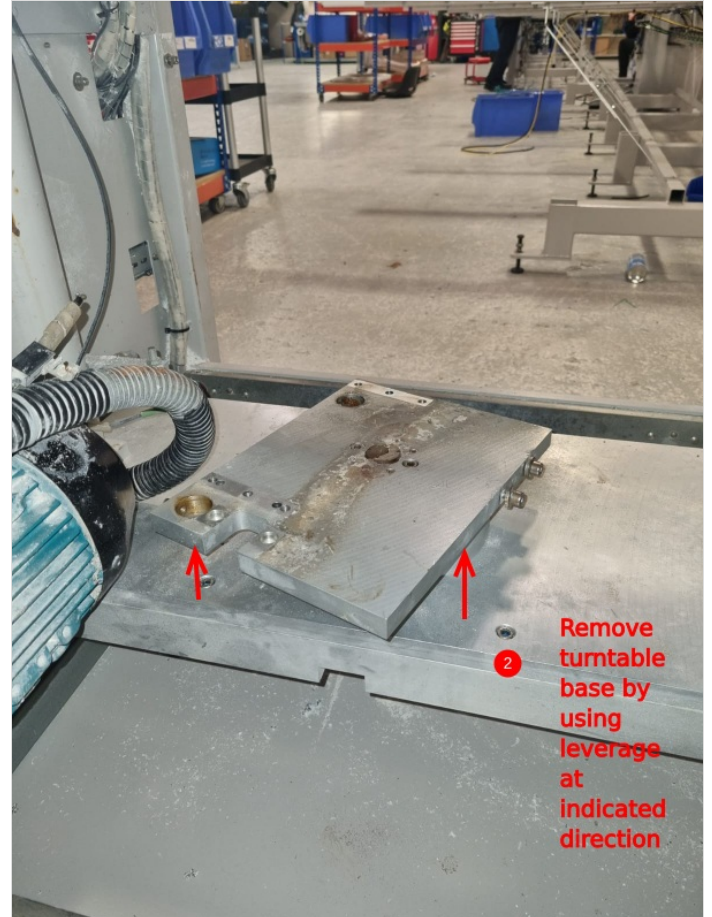
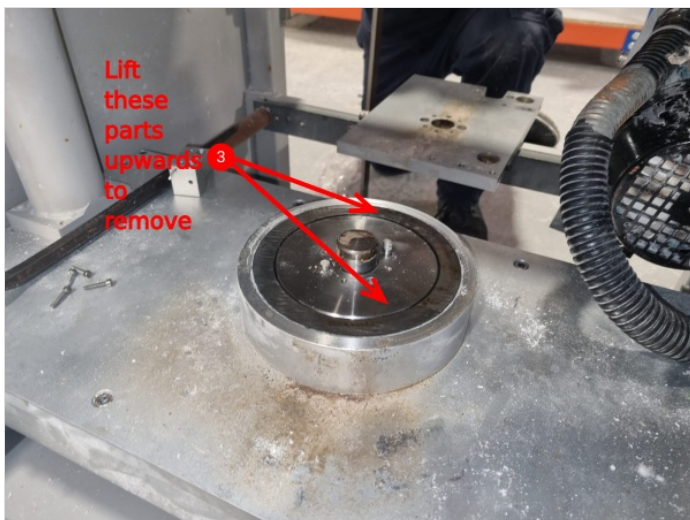
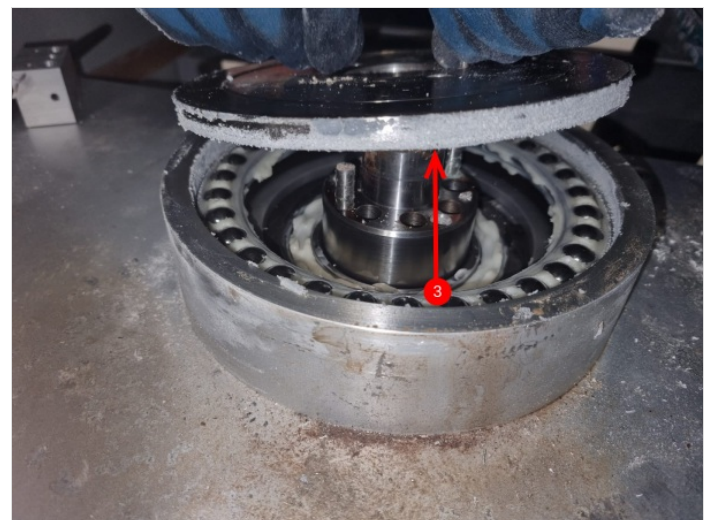
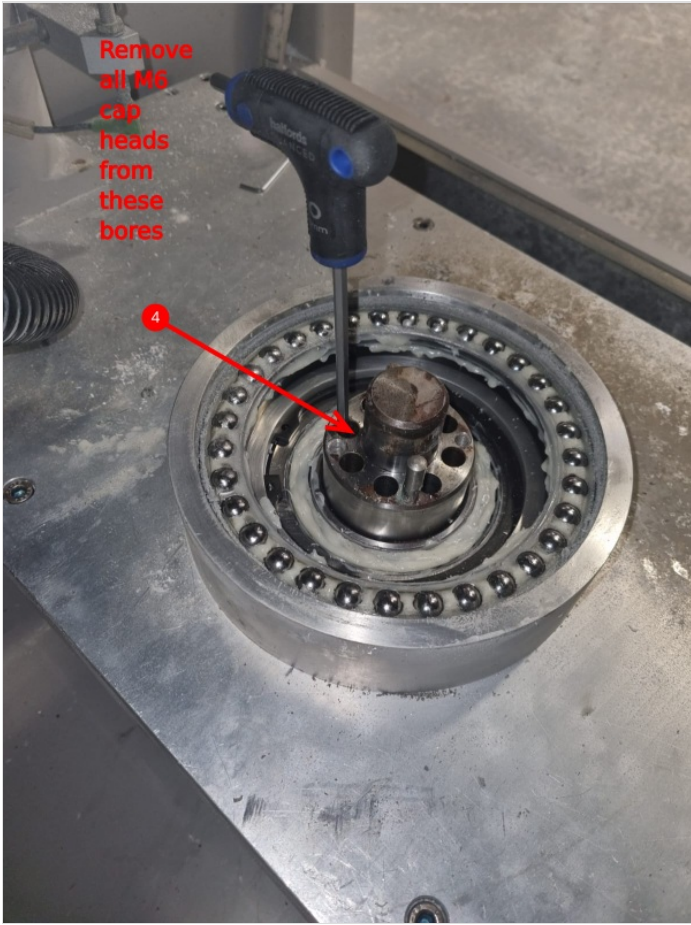
Step 6 - Turntable plate removal

1 Remove the m8 caps from the top face off the turntable plate, along with the 4 off m4 caps. The remaining 8mm dowels visible cannot be extracted, but will be released once the turntable plate is removed.

2 To remove the plate, use leverage to force the plate up evenly, to expose the main bearing and alignment disc below

3 Now the top section of the main bearing and alignment disc can be lifted off, exposing the bores to access the gearbox fixings.

4 Remove the m6 cap head bolts as shown

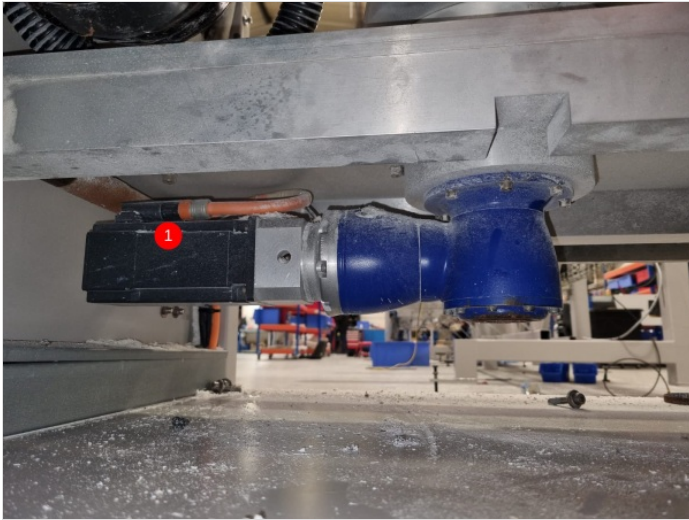
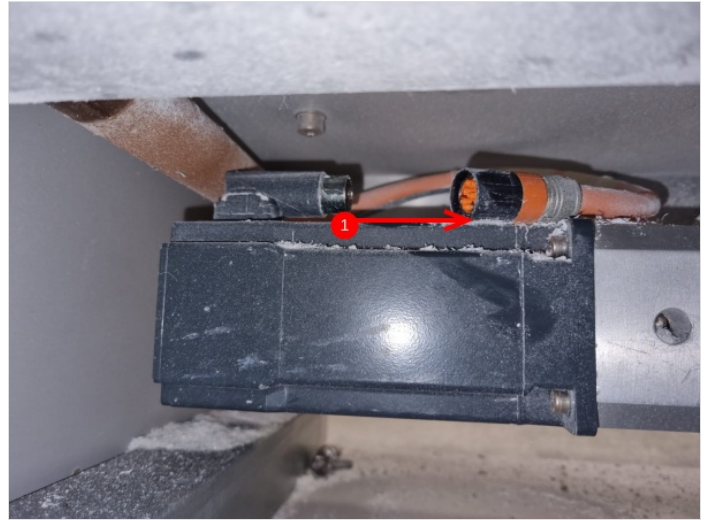
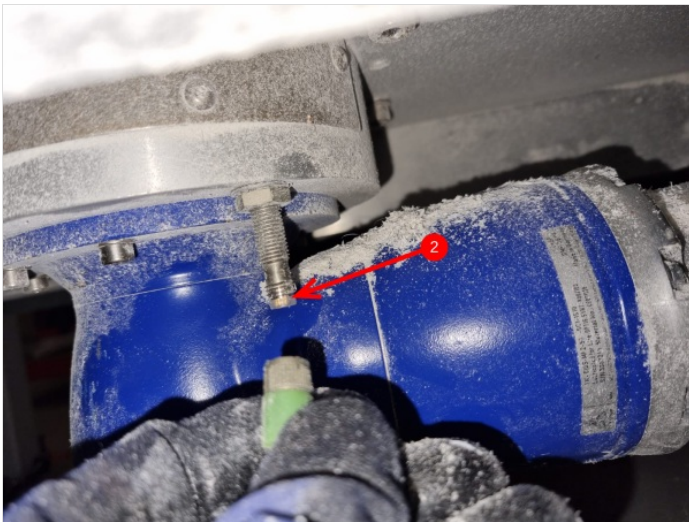
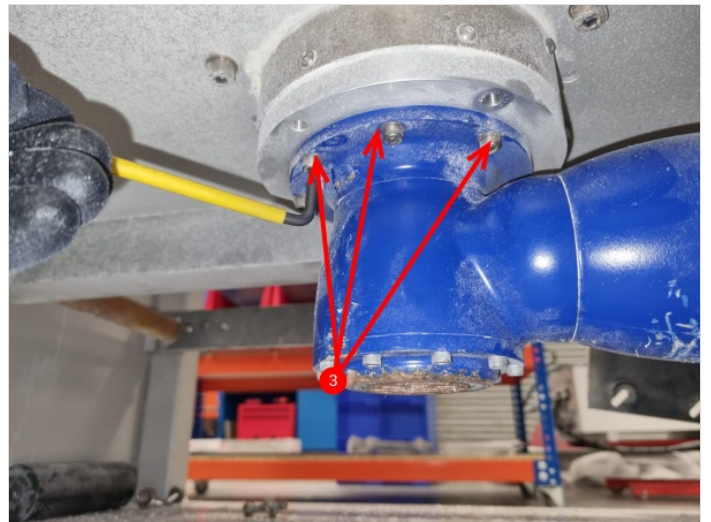
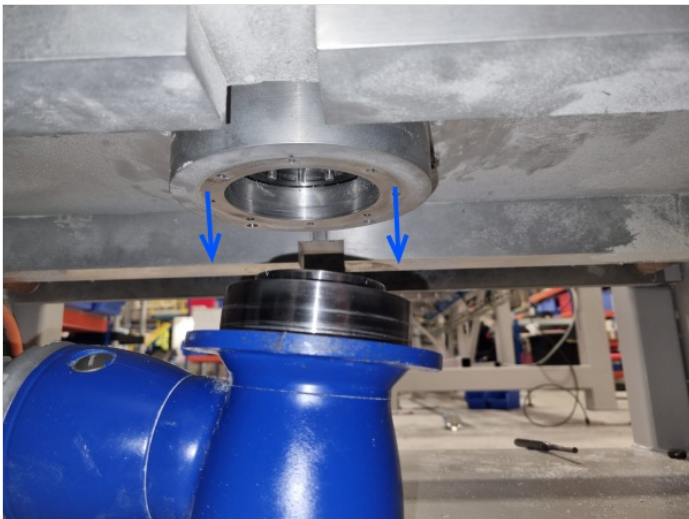
Step 7 - Lower turntable disconnections

1 Disconnect the servo motor plug

2 Disconnect (if present) the m8 sensor plug

3 Remove m5 fixings around gearbox mounting flange to allow the gearbox and motor to be removed

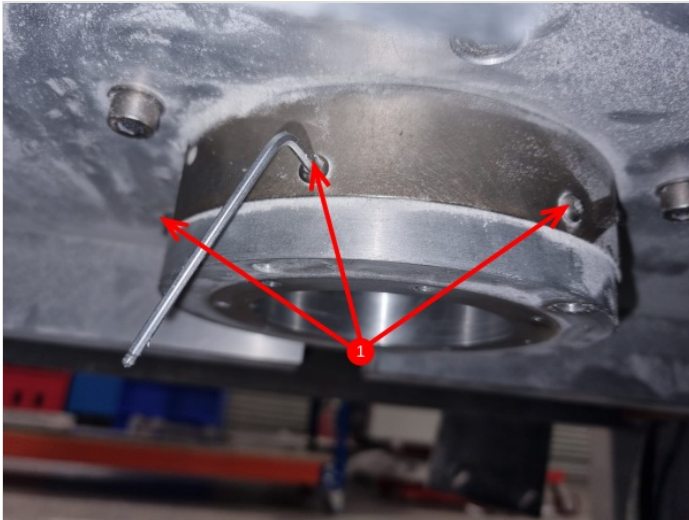
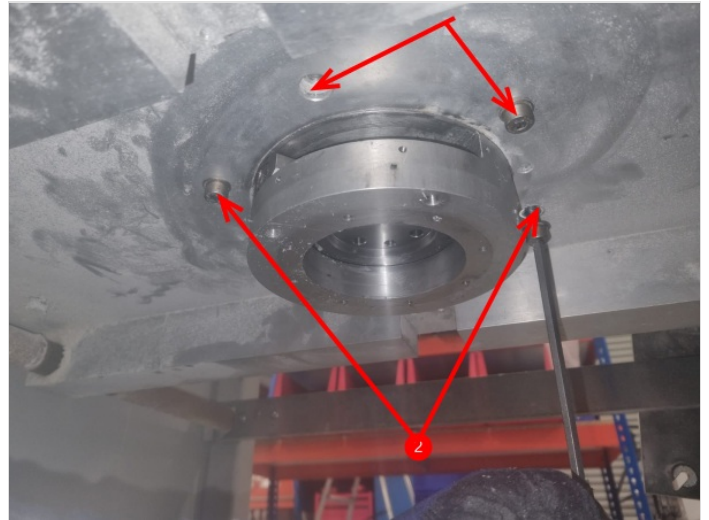
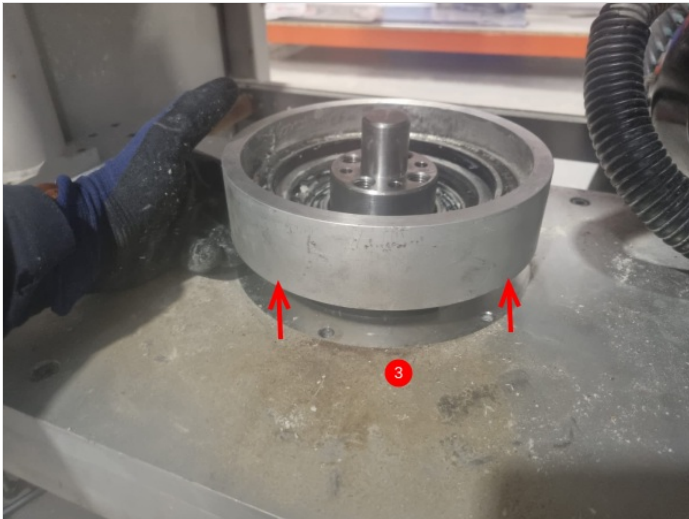
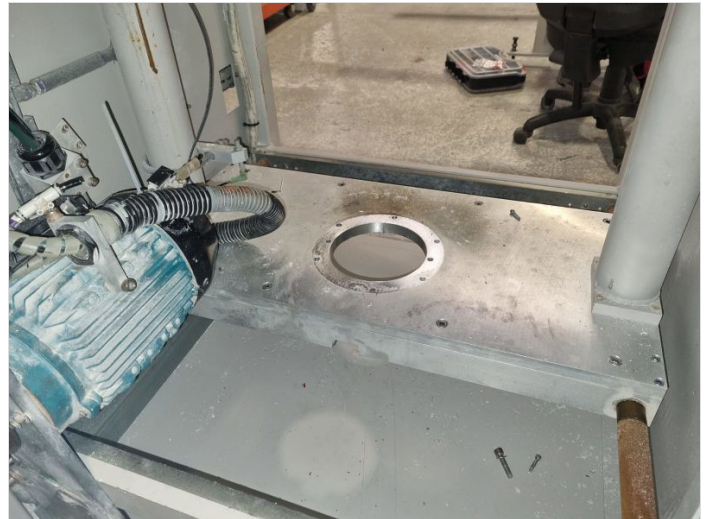
Step 8 - Lower turntable disconnections

1 Remove stainless inspection cover

2 Remove 6 off m8 cap heads

3 Main turntable housing can now be removed, by lifting upwards through the main bottom plate

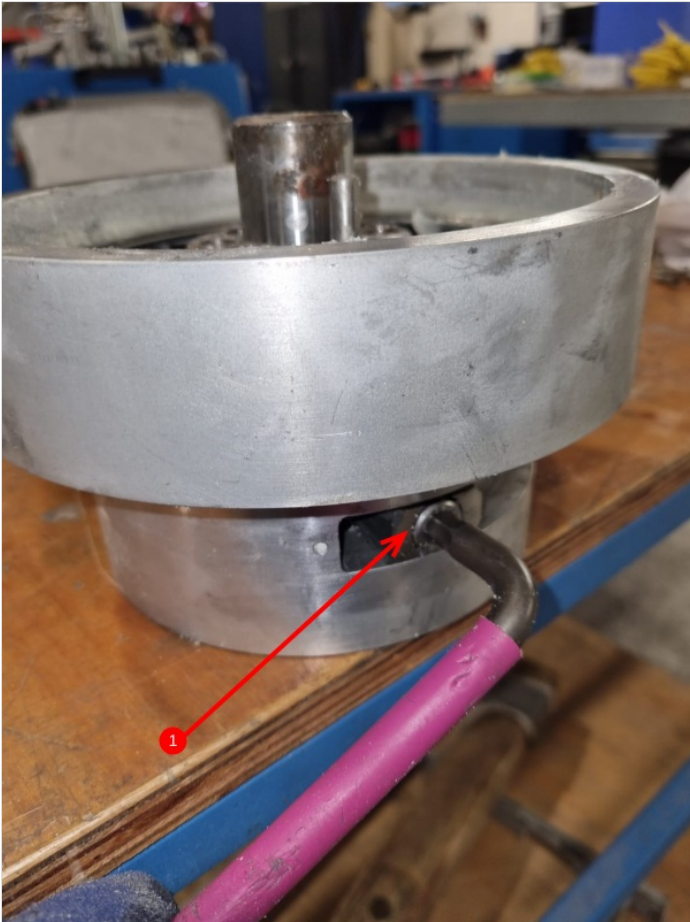
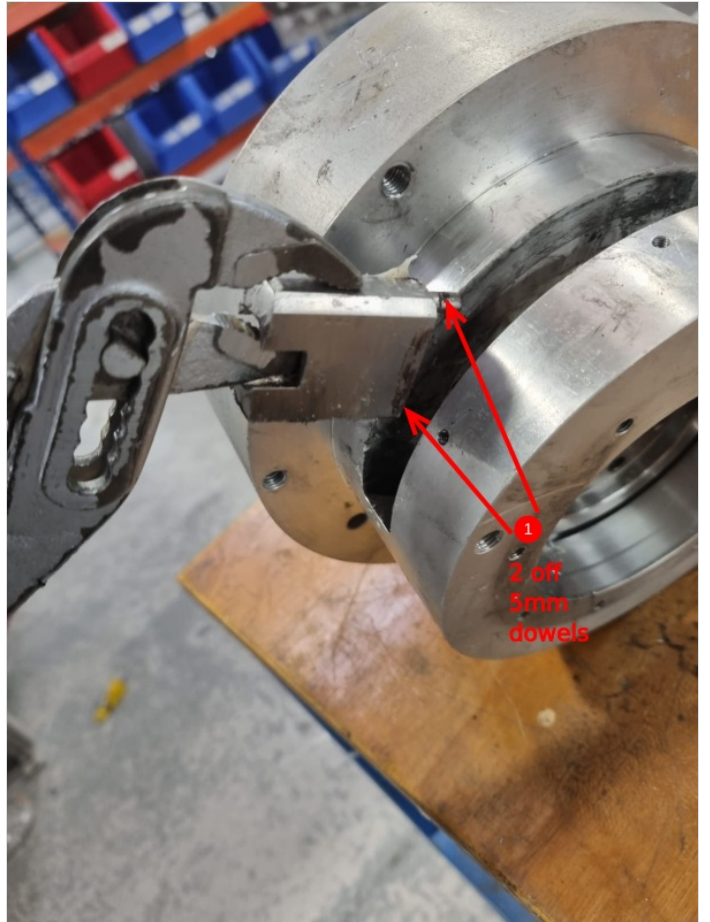
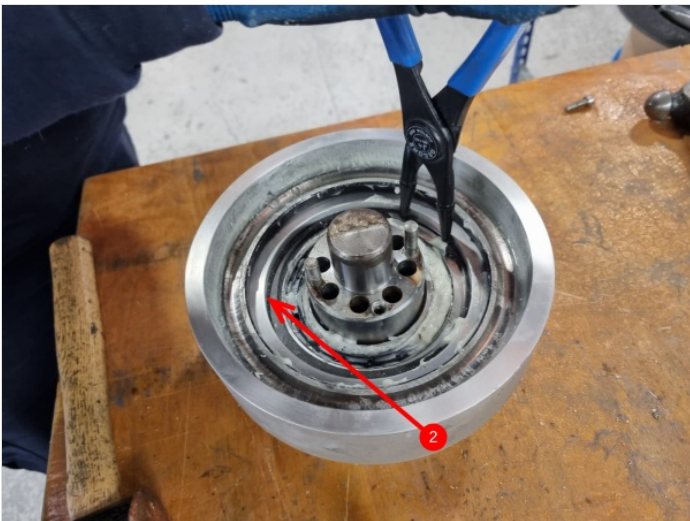
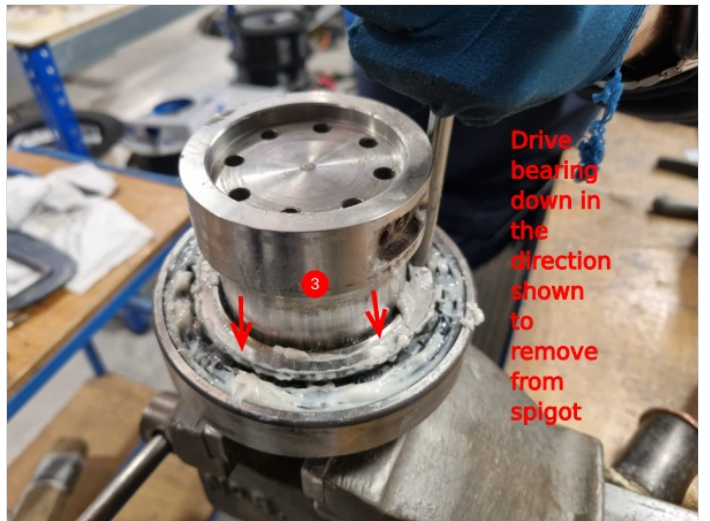
Step 9 - Spigot pin removal

1 Remove hard stop, attached with 1 off m10 bolt and 2 off 5mm dowels

2 Remove internal circlip that captivates the centre thrust bearing

3 Remove bearing and spigot assembly as one from within the main bearing housing, and then remove bearing from the spigot shaft

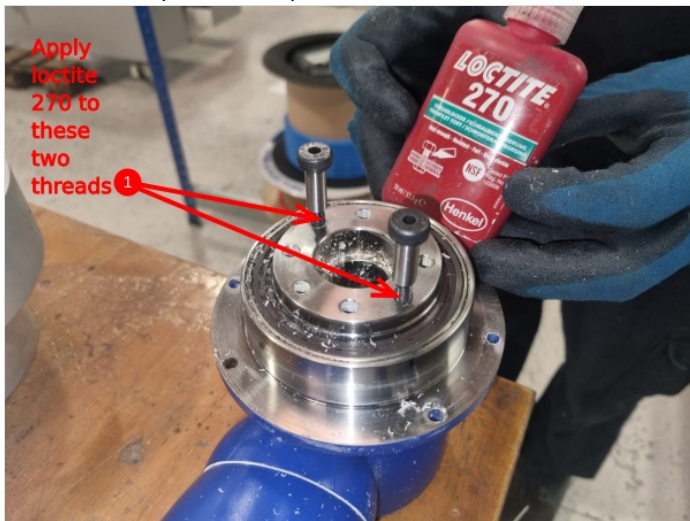
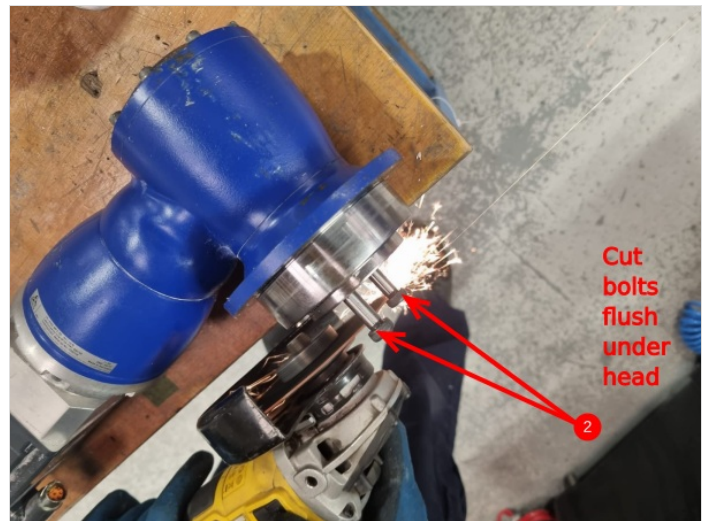
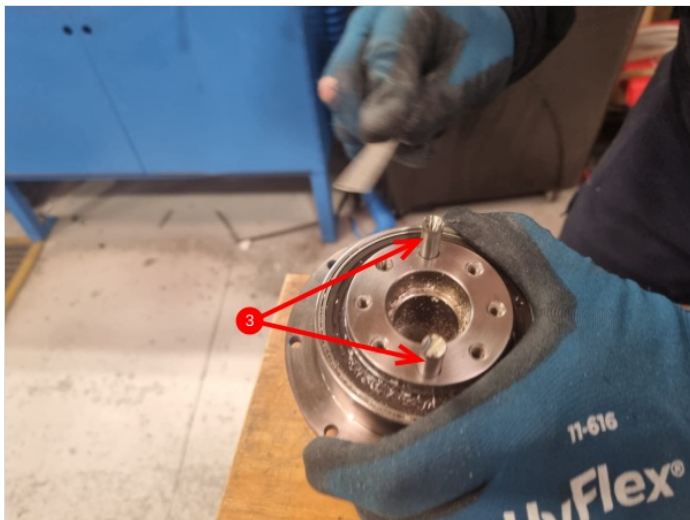
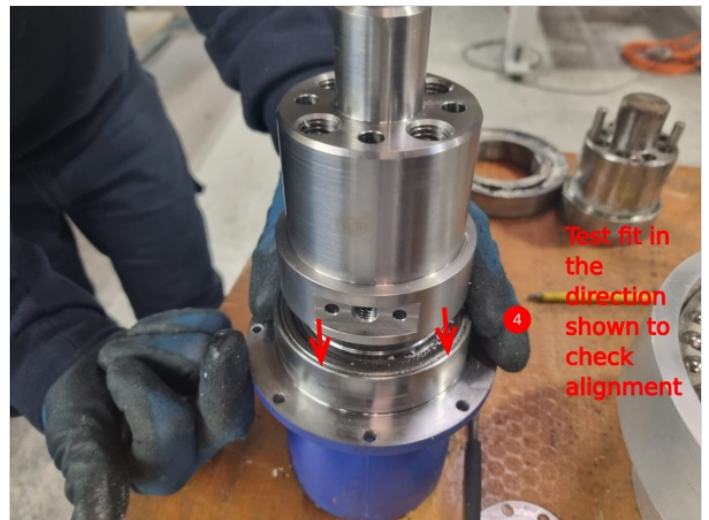
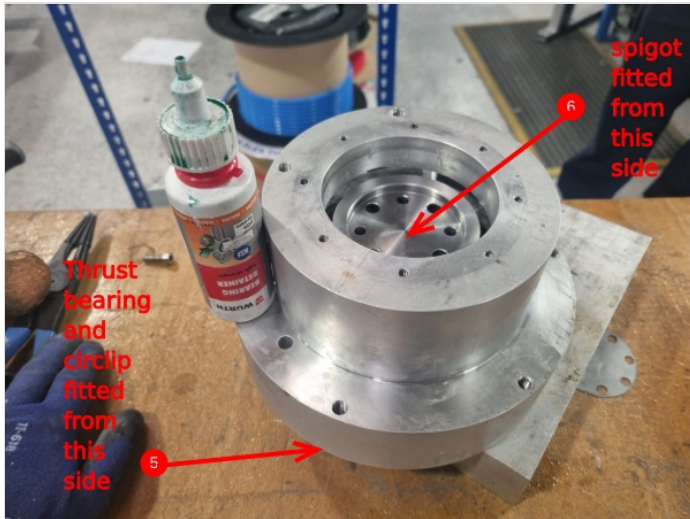
Step 10 - Gearbox dowel pin fitting

- 1 Fit 2 off m6 shoulder bolts to opposing m6 holes on gearbox mounting face and glue with loctite 270 permanent adhesive
- 2 Remove heads of shoulder bolts once tight
- 3 Deburr cut dowels
- 4 Test fit onto new d0004147E spigot shaft
- 5 Refit thrust bearing to main saw turntable housing and refit circlip

⚠ ...Correct orientation of thrust bearing is paramount, Large inner face of bearing should face the gearbox side of the assembly

- 6 Fit spigot shaft back into thrust bearing .

⚠ ...If the fit is not resistive, use degreaser and bearing fit to the two mating faces to ensure correct operation of the bearing

- 7 Refit hard stop to assembly

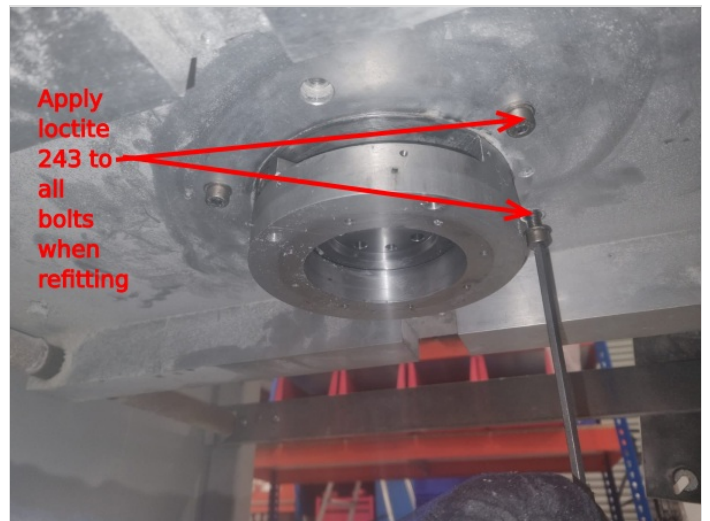
Step 11 - Refitting bearing housing

Refit bearing housing assembly to main plate
