R0019207 Upgrade SR Axis Spigot

Upgrade to enhance mechanical connection between drive spigot and SR gearbox. Upgrade to allow removal of SR gearbox efficiently

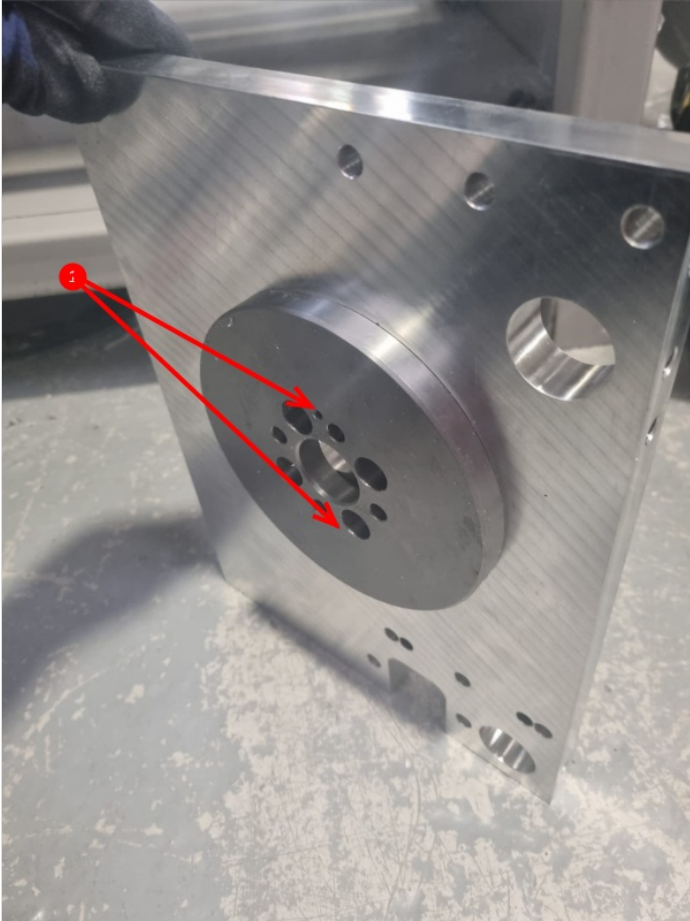
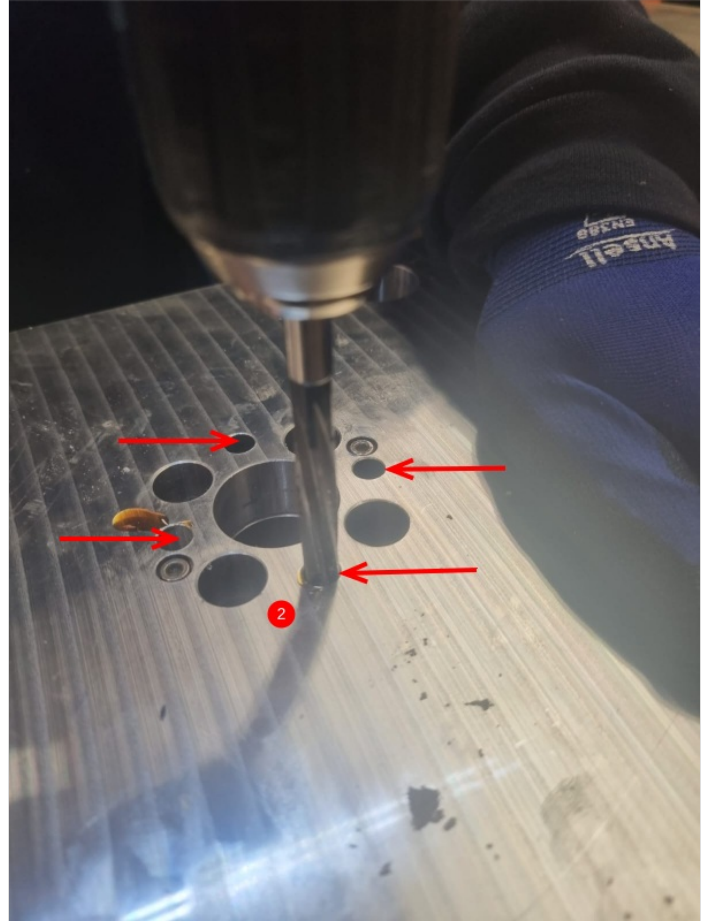
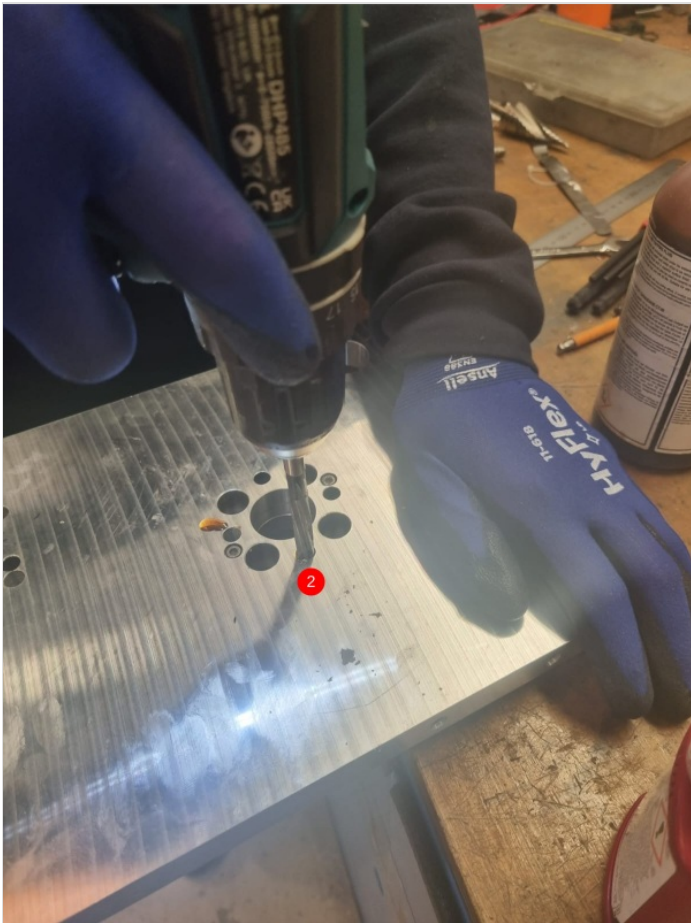
Step 12 - Fitment of alignment parts

1 Assemble alignment disc to bearing outer . Hold in place with slightly tensioned M4 caps

2 Use an 8mm reamer to check holes will accept an 8mm dowel through both parts

3 Fit bearing outer cage onto alignment disc

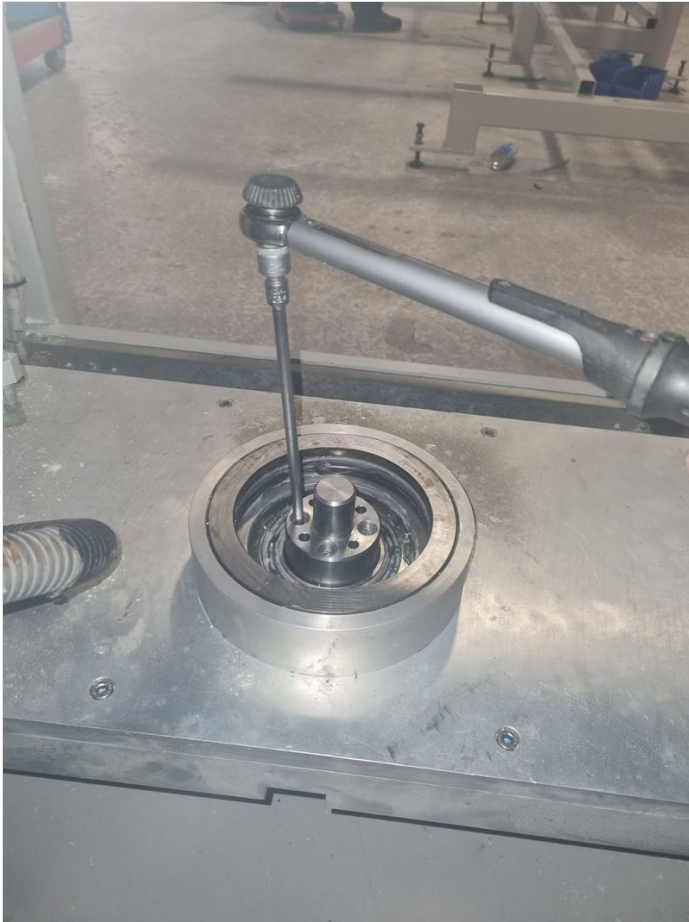
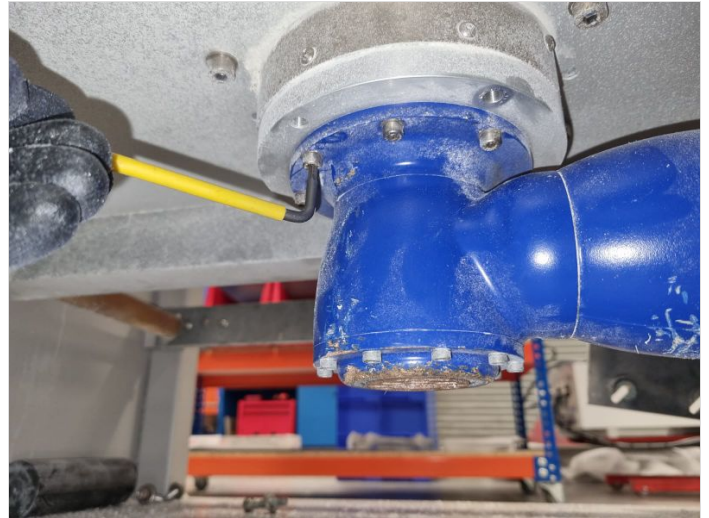
Step 13 - Fit Sr axis gearbox

Connect the gear box , using the 2 dowels on the gearbox as location, then using 4 off m6 x 20 blackadised unbrako bolts, loctite 243 and M0001176 4 off stainless lock washers to connect the parts together. Torque setting on 15nm should be used to set these m6 bolts

Refit m5 Fixings to lower gearbox flange from underneath turntable

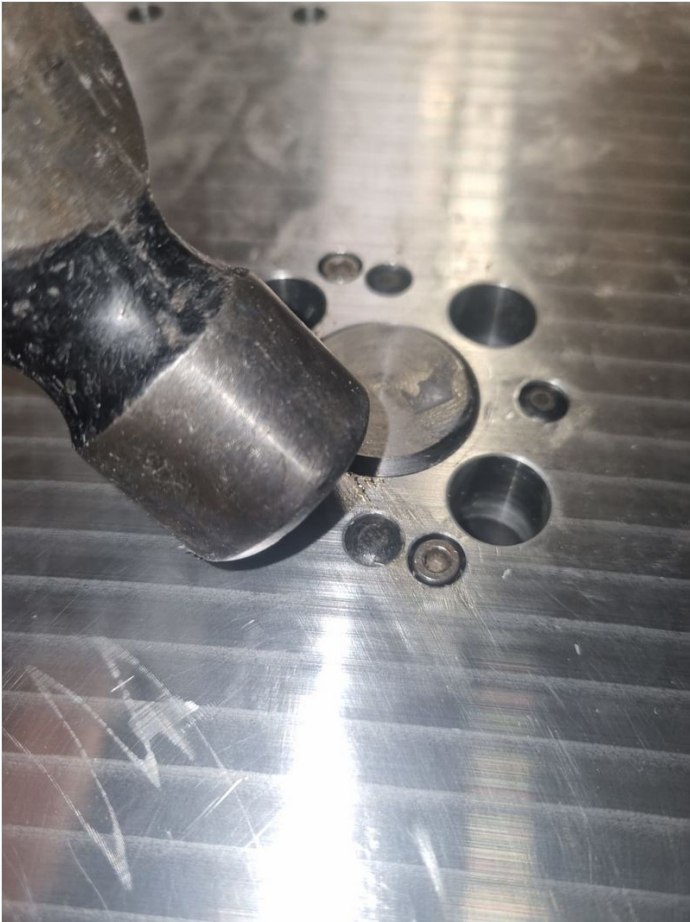
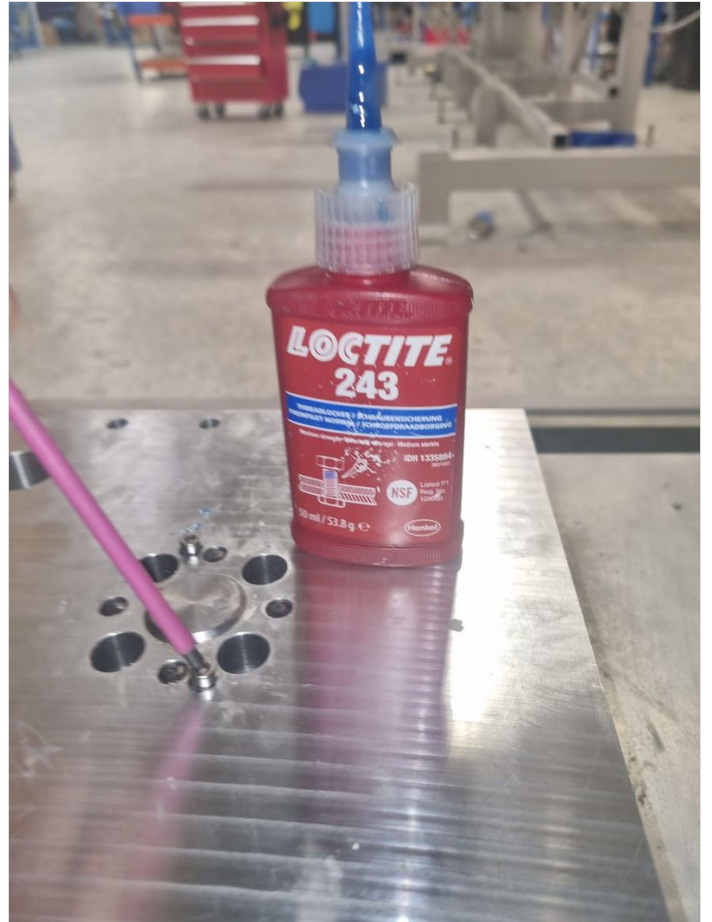
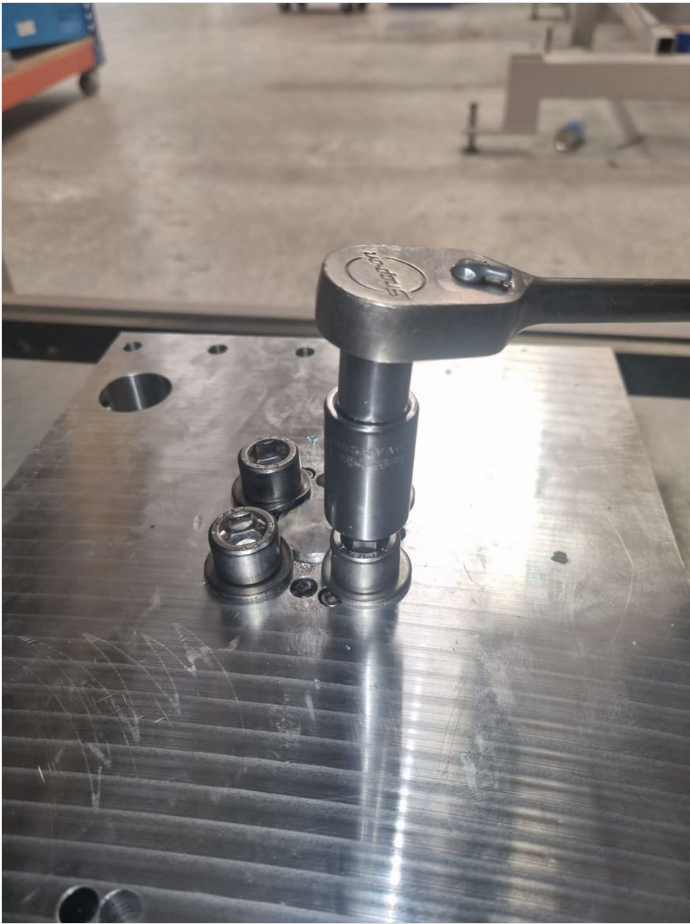
Step 15 - Fit turntable plate

Place turntable plate D4019E onto greased assembly , and fit 4 off 8mm dowels to fix all three new addition parts together.

Then apply adhesive to m4 caps and tighten.

Lastly fix with 4 off m14 bolts and a form washers to finalise turntable plate into position

Check rotation is smooth by hand by turning the turntable plate and check the range of movement is correct

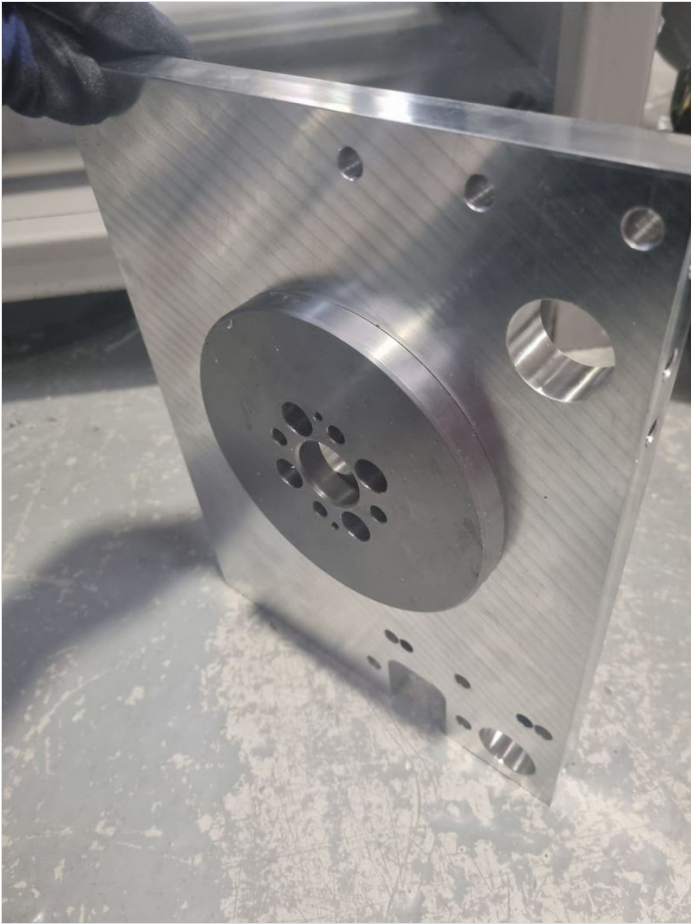
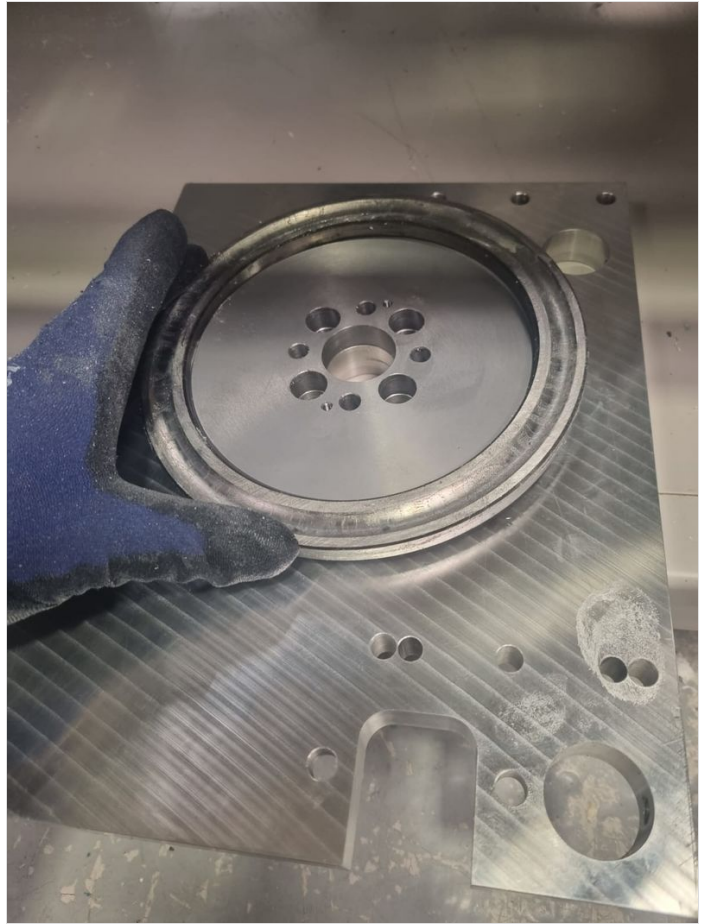
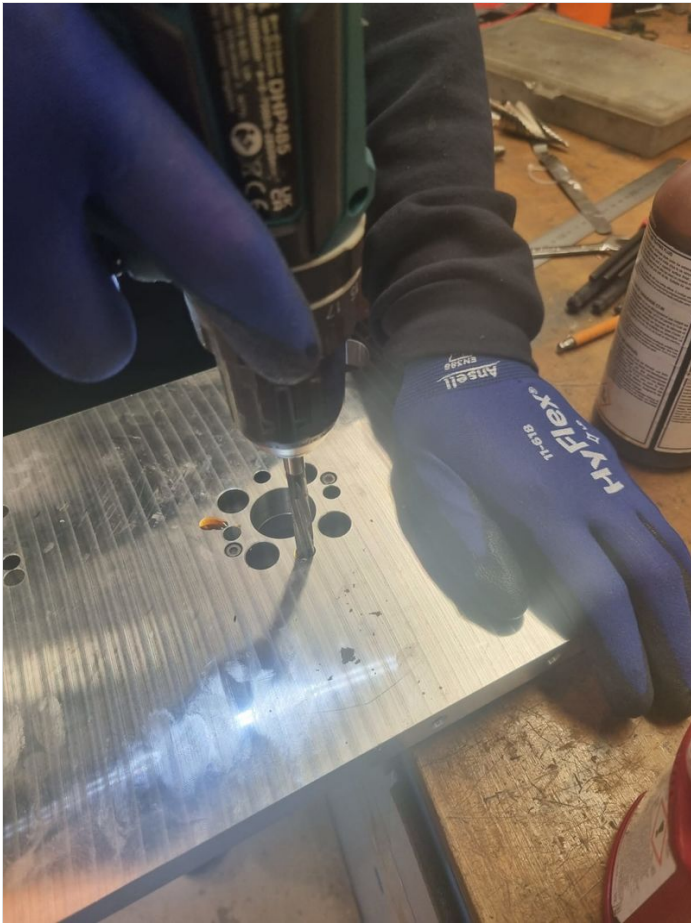
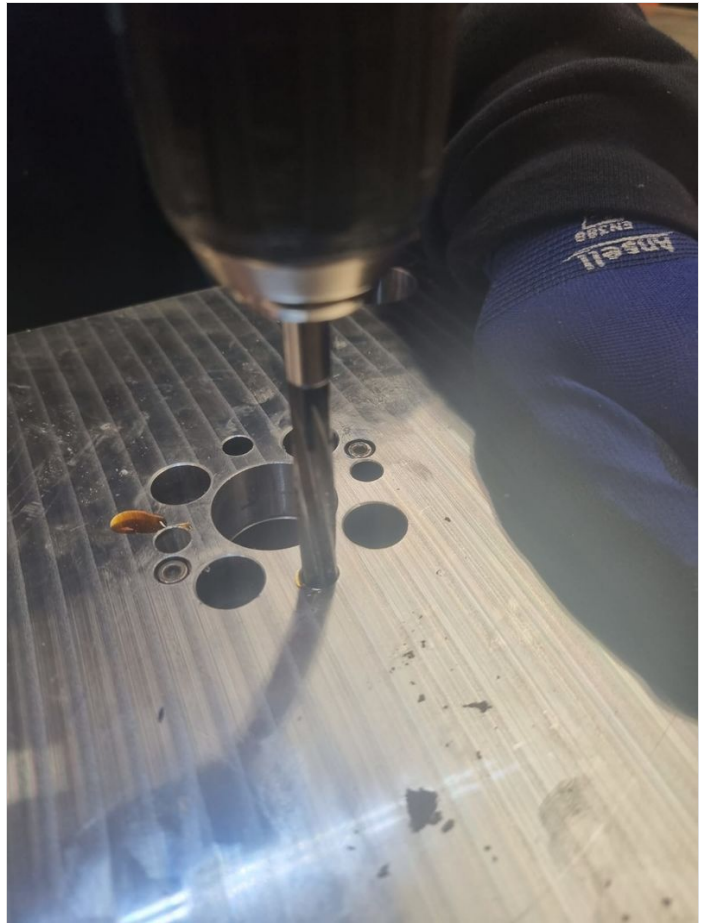
Step 16 -

Assemble alignment disc to bearing outer . Hold in place with slightly tensioned M4 caps

Use an 8mm reamer to check holes will accept an 8mm dowel through both parts

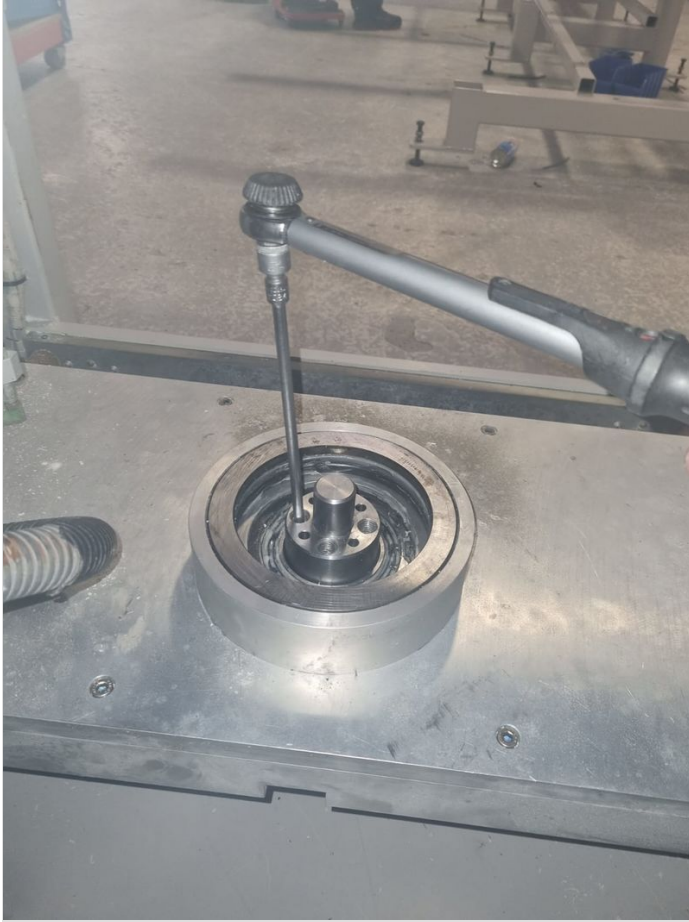
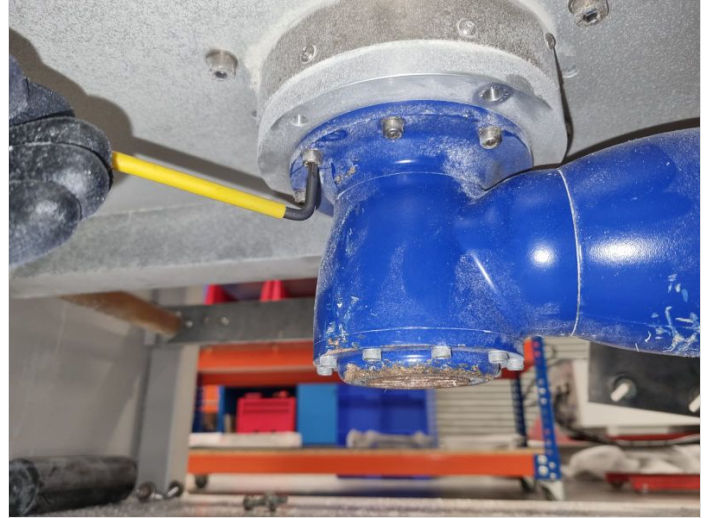
Step 17 - Fit Sr axis gearbox

Connect the gear box , using the 2 dowels on the gearbox as location, then using 4 off m6 x 20 blackadised unbrako bolts, loctite 243 and M0001176 4 off stainless lock washers to connect the parts together. Torque setting on 15nm should be used to set these m6 bolts

Refit m5 Fixings to lower gearbox flange from underneath turntable

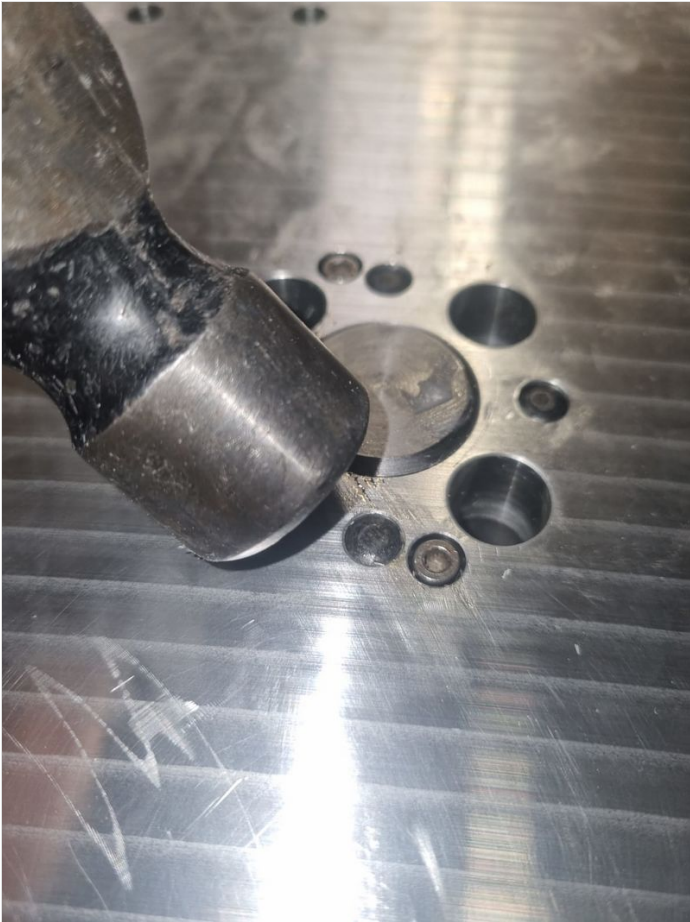
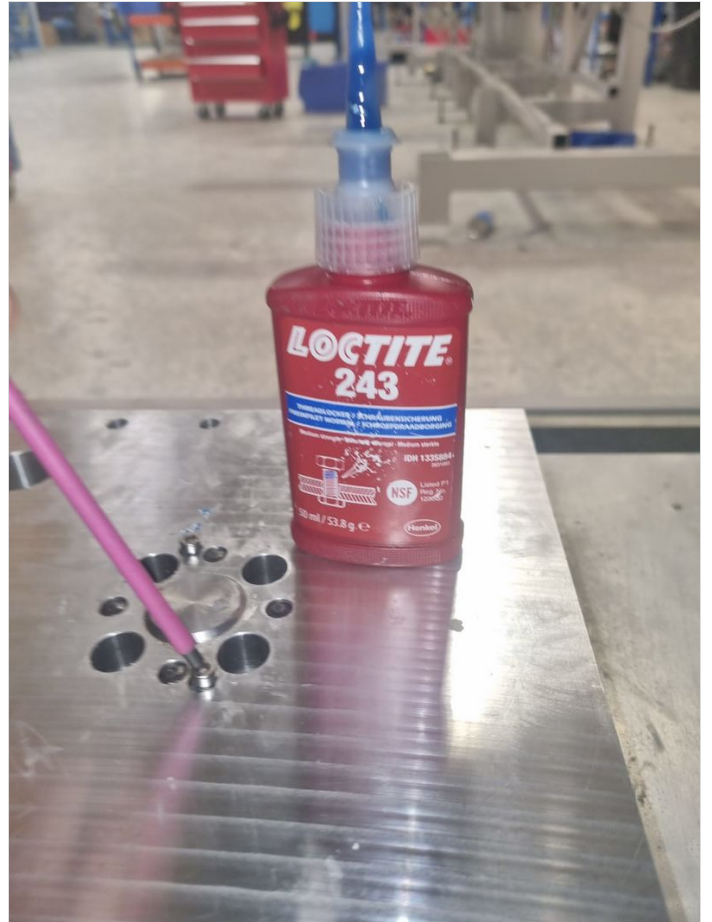
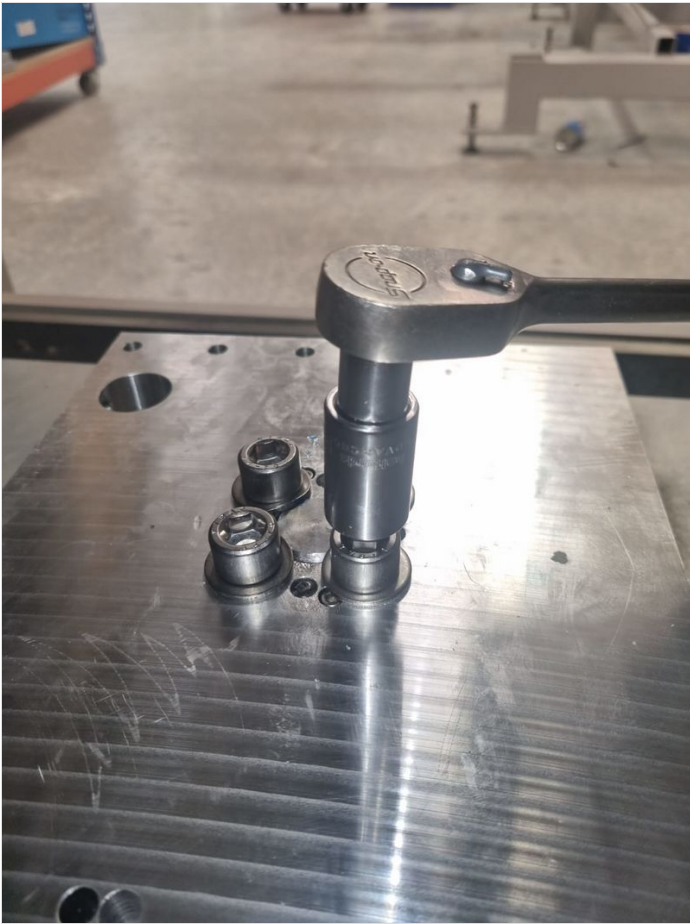
Step 19 - Fit turntable plate

Place turntable plate D4019E onto greased assembly , and fit 4 off 8mm dowels to fix all three new addition parts together.

Then apply adhesive to m4 caps and tighten.

Lastly fix with 4 off m14 bolts and a form washers to finalise turntable plate into position

Check rotation is smooth by hand by turning the turntable plate and check the range of movement is correct
