# Saw Chute Blade Nut Clash

How to temporarily prevent the saw blade nut from clashing with the chute

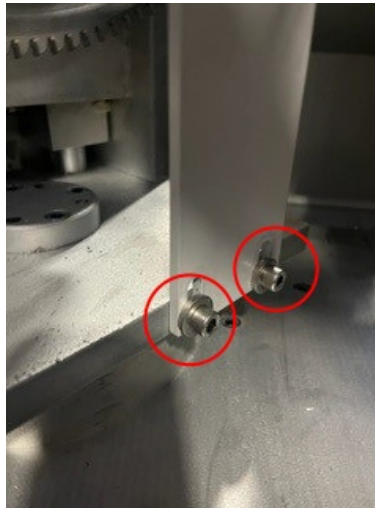
The chute mounting system becomes dislodged causing the chute to move sideways into the blade nut. As well as the obvious damage to the machine, this can lead to the nut coming undone.

The consensus is that the root cause is the top half moon plate is getting pushed over when an offcut gets trapped. This happens on ZX5s because we have a servo motor, through 100:1 gearbox, driving the rotation rather than the tandem cylinder. The top half moon plate is only held with a couple of M6 countersinks. Its been the same since 1992 but this design is now not fit to handle the servo / gearbox combo.

To improve the situation, the chute can be angled away by fitting spacers to the bracket mounting
