# TB0433 Incorrect Configuration of Air Service Unit

This bulletin demonstrates the incorrect orientation of the pressure sensor dial on an air service unit. This is a regular supply issue. If an item is received like this, it must be returned to the supplier for replacement. If the unit is needed urgently, it will have to be dismantled and rebuilt correctly.

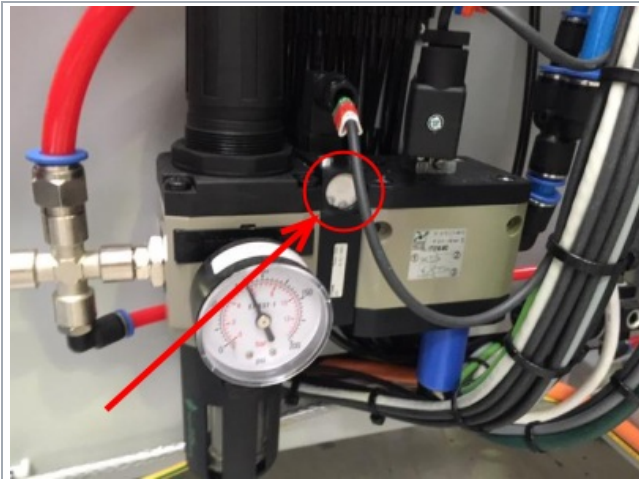
Incorrect- dial is not visible
