TB0287 Importance of Outfeed Clear Sensor

TB Number:	287
Originator:	Gareth Green
Machine:	Flowlines, ZX
Date:	18/08/2015
Circulate to:	Service
Title:	Importance of Outfeed Clear Sensor

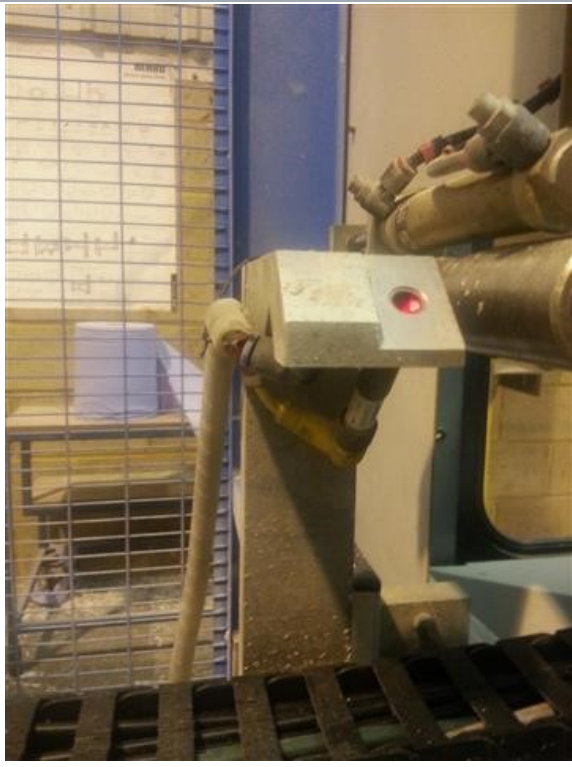
ZX3/4 Mounting	Flowline Mounting
----------------	-------------------

If the part is faulty, it needs to be replaced with:

1 off E0000231 sensor

1 off E0000375 cable

A ZX3 / 4 machine may not have this part fitted and would need the following kit (see TB0161 for fitting, but ignore software part as this is for Neuron machines).
