# TB0401 Overcoming Backlash Adjustment Limitation

On the Hepco rack / pinion / journal system, it is possible to get into a situation where no more adjustment is available using the motor mounts.

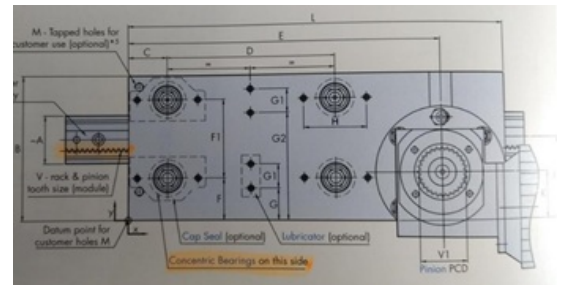
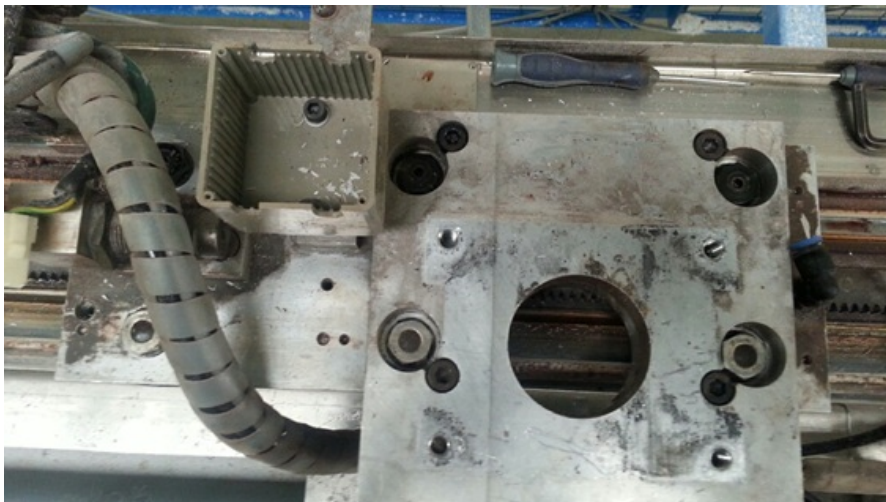
This means that if the journals now wear, the eccentric journals can take up the slack, and the pinion will move into mesh with the rack. Photo shows the assembly after the journal position was swapped at Glazerite.

Check which side the eccentric journals are mounted on. If they are on the rack / pinion side, swap them over to the other side.

The correct Hepco recommended side is for the concentric bearings to be on the rack side
