TB0420 Obsolescence Note - Flowline Spindle Motors

The original motor is no longer available, and a replacement has proved impossible to find due to the physical size of the motor

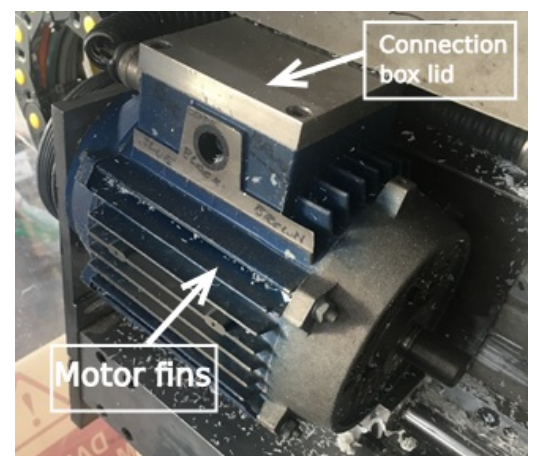
Part Nos	Description
D0008252	Std Hand
D0007342	Opp Hand
E0000219	Original Motor 71/B14 2 Pole 0.75kW

Stuga have a small stock of second-hand motors. The recommendation is to get the motors rewound locally to the customer site – Stuga are unable to offer this service.
